## CASE HISTORY

### Bedrock Fracture Mapping For Site Remediation Project

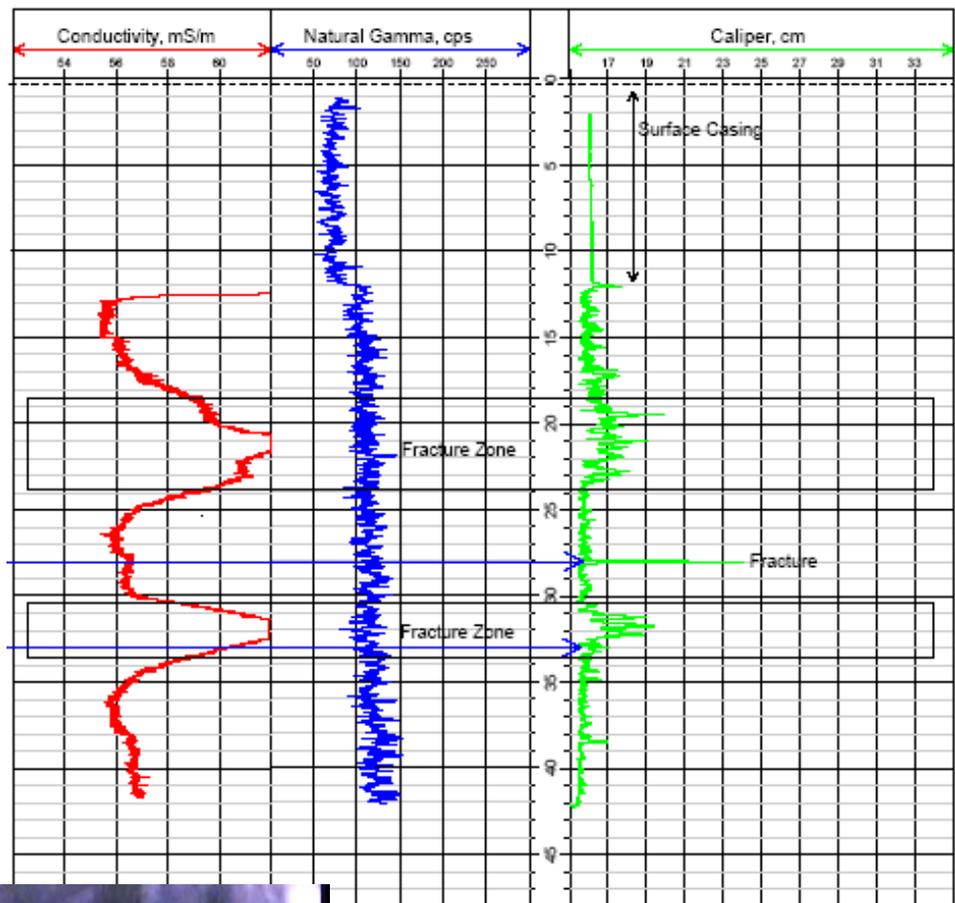
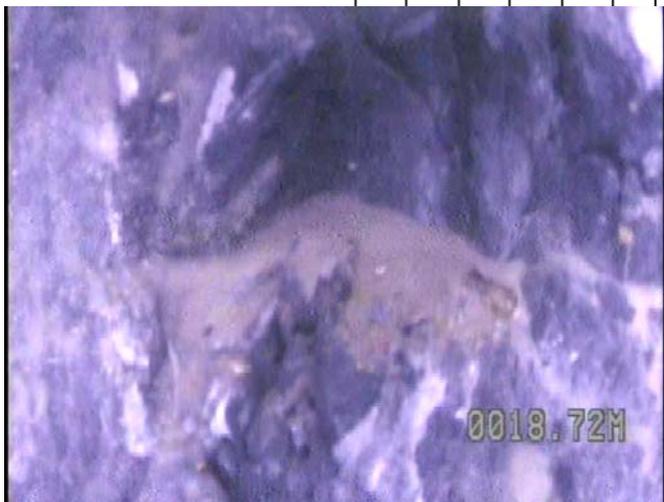
Example interpreted geophysical log with video still frame showing large fracture. Groundwater could be seen flowing into the well through this fracture and depositing the sand seen in the image (light brown material near the center of the photo).
