CASE HISTORY

Subsurface Site Characterization Using Downhole Logging Tools

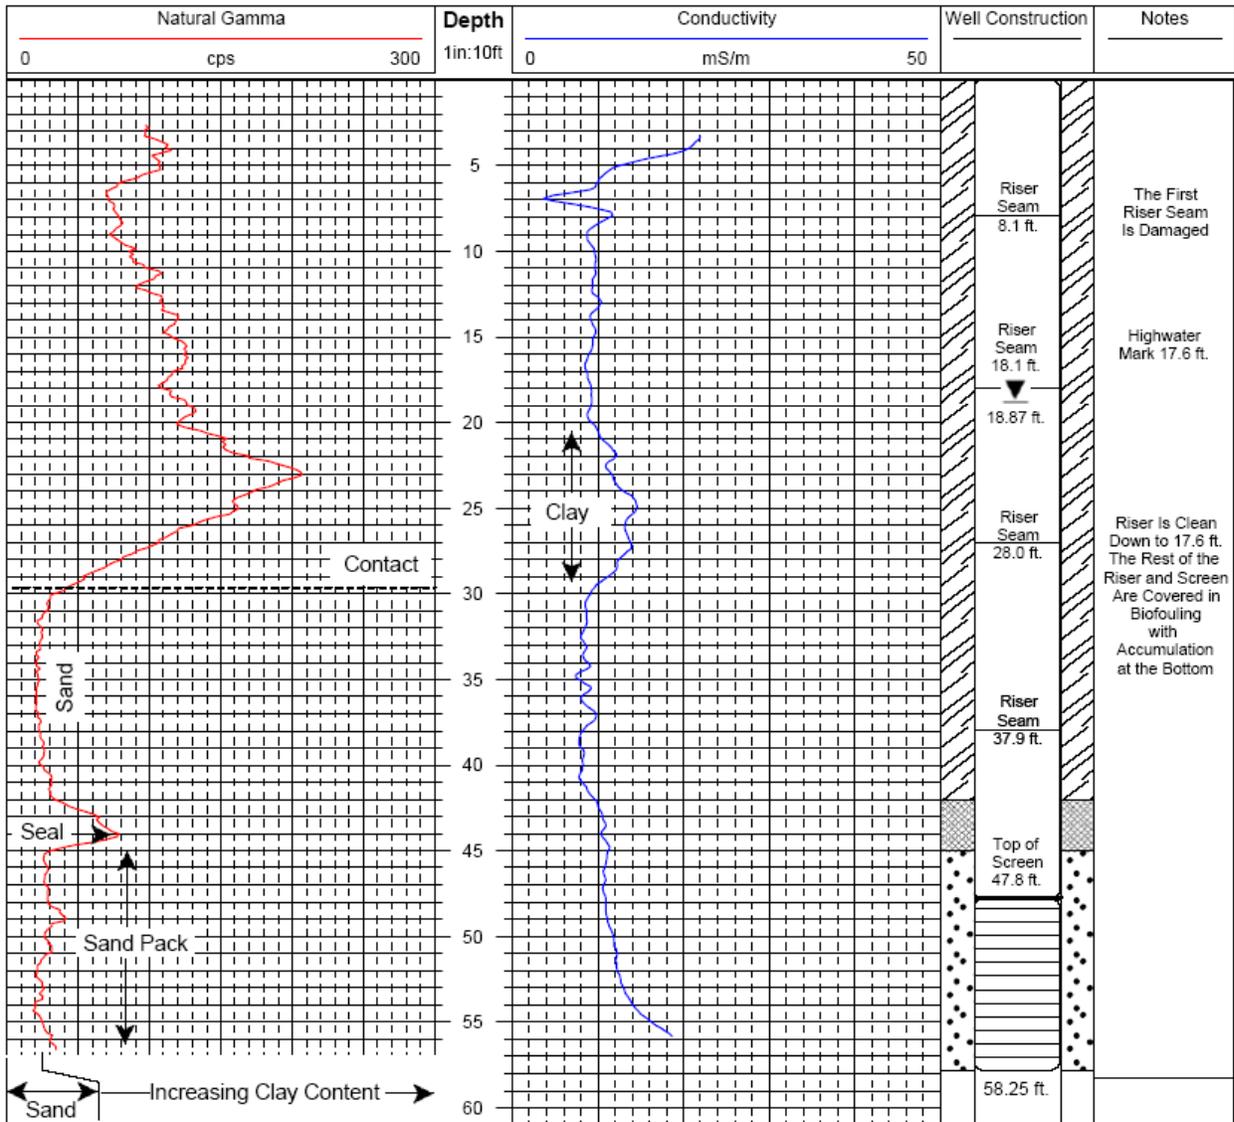
To estimate the geologic conditions of the site, natural gamma and electromagnetic conductivity logs collected to provide information on the annular fill materials, as well as the materials outside the annular space. An example of these logs, as well as the well construction results determined from the downhole camera, can be seen in Figure 1.

Figure 1. This figure shows one of the complete well logs compiled by MUNDELL. The geologic information is presented as well as the well completion diagram.

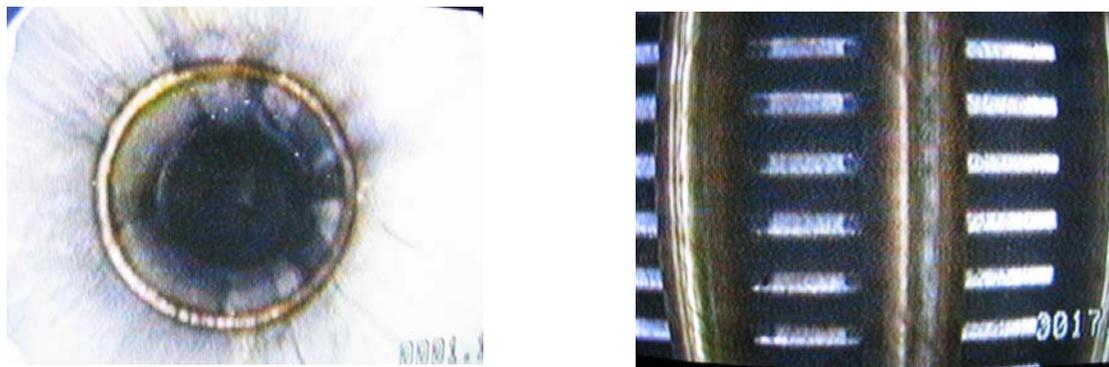
Figure 2. These photos are views of a stainless steel well as seen from the downhole camera. The photo on the left is a riser seam, while the photo on the right is the wire-wrapped screen.
