## CASE HISTORY

### PLC Control Program Alteration

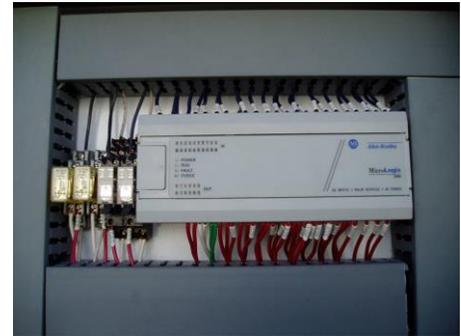
The operation of a remediation system overseen by MUNDELL was observed to be inefficient. The system's logic program was actually damaging the equipment. The PLC control program for the system was written in such a way that when an alarm condition was detected, the system shut down for 10 minutes and then reset itself instead of remaining idle until manually reset by an O&M technician. This caused equipment to cycle on and off rapidly, causing undue wear. This also prompted concerns about water treatment since the equipment was repeatedly shutting down. Thus, when an alarm condition occurred, this self-restarting of the system required the technician to plan a site visit almost immediately. Another complication that arose from the programming was that because of the built in reset, the system could not be reset manually on site. The technician would have to wait the 10 minutes for the system to reset if an alarm was inadvertently triggered by routine maintenance or for troubleshooting purposes.
