**Second
International Conference
on
Case Histories in
Geotechnical Engineering**

Excessive Seepage Losses at Westwood Lake Dam

SYNOPSIS: Excessive seepage losses at Westwood Lake Dam in east-central Indiana were apparent in 1974 during first filling of the lake when seepage areas developed downstream of the dam and abutments. Several remedial studies were performed which included additional test borings, field and laboratory tests, installation of observation wells, and a review of the site geology and hydrology. Data and observations from these studies were used to develop semi-quantitative assessments of seepage loss rates as related to lake levels. These analyses served as a basis for design of a major repair which consisted of blanketing a significant portion of the lake bottom with on-site, low-plasticity clays and clayey silts. The blanketing was completed in 1984 and post-repair filling required about two years. Subsequent monitoring and observations indicate that the lake level is holding at or within 1.5 ft of the original design normal pool.

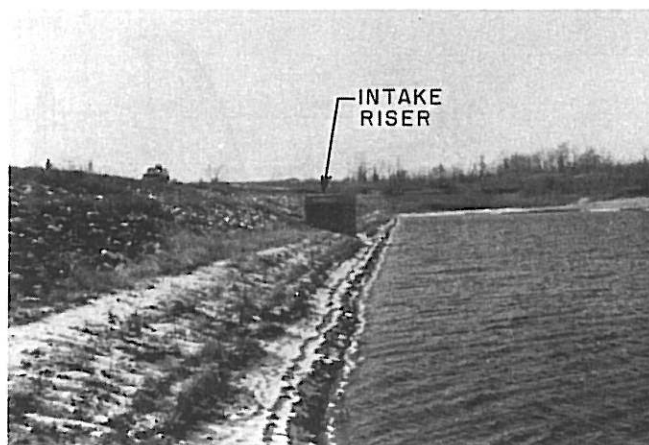
Figure 1. Pre-Repair Lake Below Intake Riser (Normal Pool) Control on Upstream Slope of Dam

Several series of post-construction test borings were drilled and groundwater observation wells were installed at intervals between 1975 and 1980. Records of lake elevations also have been maintained since 1975. Lake levels have fluctuated between Elevation 994 in October, 1977 and near the design normal pool (Elevation 1015.2) for a brief period in September, 1979. The typical lake level was well below the intake riser control level as shown in Figure 1.

Based on the remedial studies, a major repair consisting of draining the reservoir and blanketing of about half of the lake area was completed in 1984. This included a total of 416,000 cu yd of compacted blanket fill. The reservoir filled to the design normal pool within about two years and since has remained at or near that level.

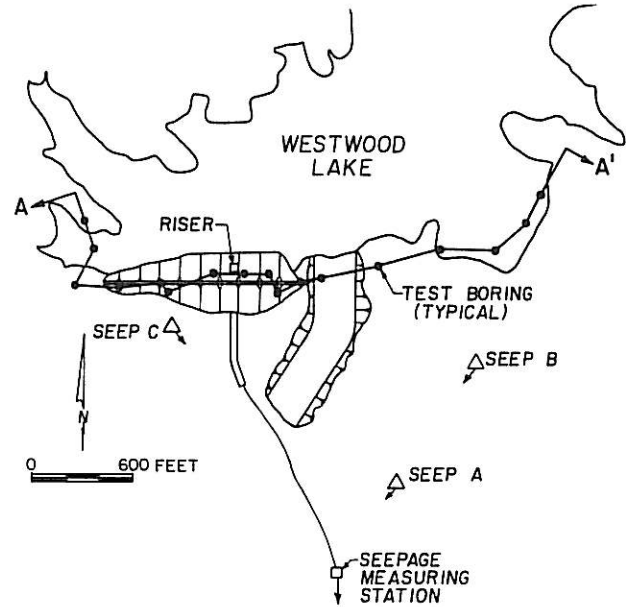
Figure 3. Locations of Site Features

These geologic considerations and test boring data suggested a southerly orientation to the granular deposits in the vicinity of the dam and abutments. The locations of several of the pre- and post-construction test borings in the vicinity of the dam are shown in Figure 3. The three seepage areas (Seeps A, B, and C) also are shown along with the seepage flow measuring station.

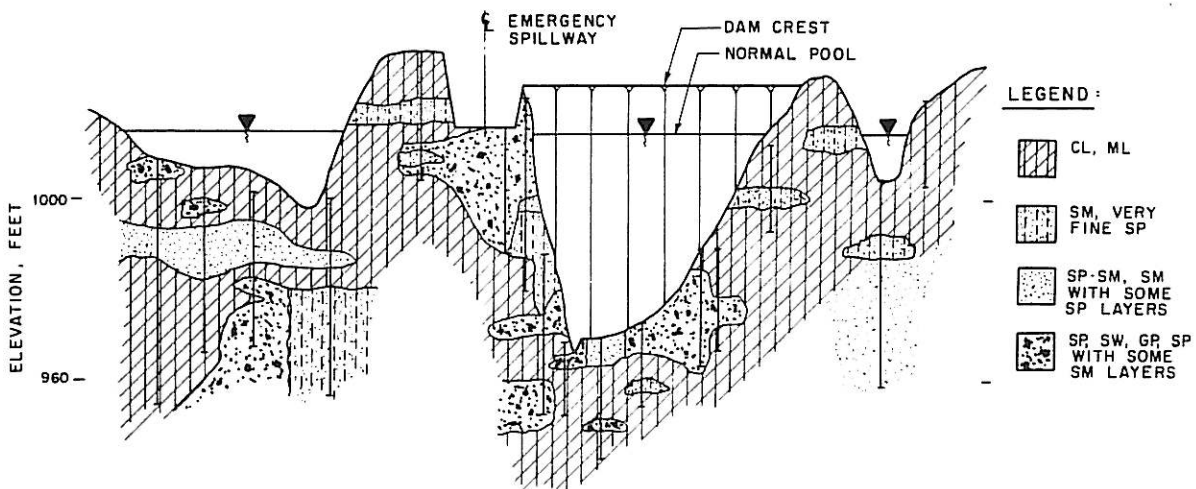
Figure 4. Subsurface Profile Beneath Dam (Section A-A', Figure 3)

A subsurface profile (east-west Section A-A') developed from these borings is shown in Figure 4. This profile illustrates the extremely complex distribution of soils with widely varying permeabilities. Within the relatively impermeable glacial till are numerous deposits or channels of granular soils. Gradations for these granular soils varied over a wide range from poorly graded coarse gravel to silty fine sands. Many of the Unified Soil Classification System groups were represented in this profile.

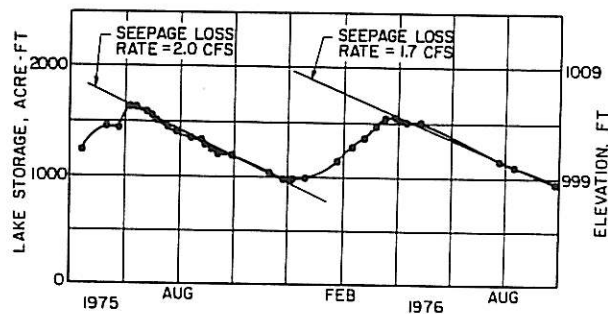
Figure 6. Total Lake Seepage (TLS) From Lake Elevation Records

From the records of lake elevation maintained after the original construction, it was possible to estimate total seepage loss rates based on the relationship between reservoir storage versus time, prior to repair, shown in Figure 6. The stream inflow was determined to be approximately equal to the evaporation loss rates during these periods.

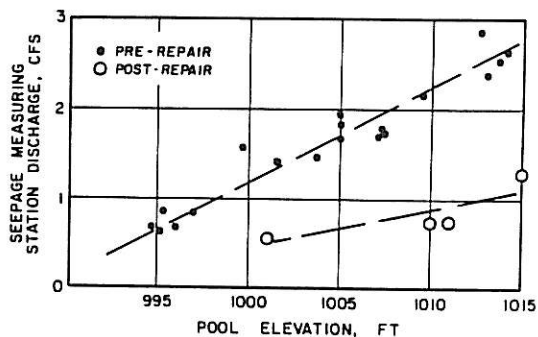
Figure 7. Measured Front End Seepage (FES), vs. Lake Elevation

Results of the observed flow at the downstream seepage measuring station are summarized in Figure 7. It can be seen that the pre-repair points (solid circles) essentially form a linear relationship with the lake elevation. The pre-repair data were also utilized to estimate the portion of the "total lake seepage" (TLS) that exited the lake through granular deposits in the foundation and abutments and was monitored downstream of the dam. This is hereafter referred to as "front end seepage" (FES). At the normal pool Elevation 1015, an FES seepage rate of 2.8 cfs was measured. A limited number of post-repair data points also are shown in Figure 7 as open circles.

During refilling, the seepage flow re-emerged, at a low rate, at Seep B. The available post-repair seepage flow measurements as shown in Figure 7 indicate that the FES level was reduced from its original normal pool rate of 2.8 to 1.2 cfs, but not to the intended design level of 0.8 cfs.

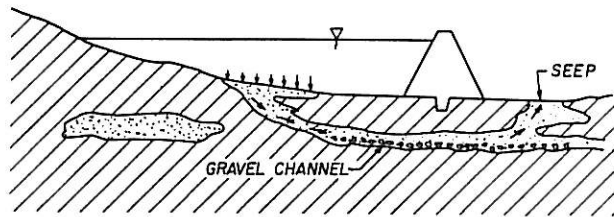
Figure 11. Possible Seepage Flow Path

upstream of the dam, suggested by the downstream location of Seep A and as depicted in Figure 11, led to the decision to extend the blanketing to a point about midway in the lake, as shown in Figure 10. This also provided a margin of safety considered appropriate in light of the very approximate nature of the above analyses.

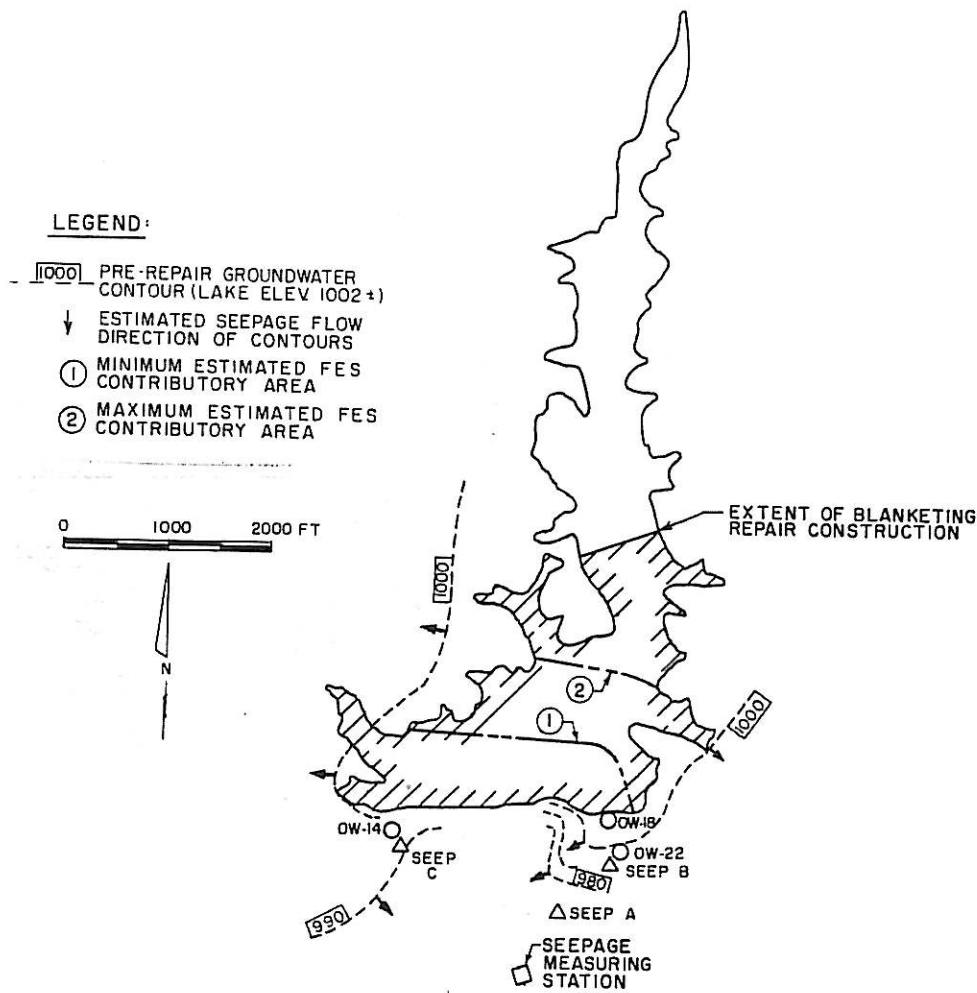
Figure 10. Estimated FES Contributory Areas and Extent of Blanketing

The extent of the contributory area to FES seepage was estimated based on the locations of Seeps A, B, and C, measured groundwater levels in observation wells, regional topography, and water well data. Although regional flow nets were judged to be only marginally applicable to such a heterogeneous soil deposit, probable flow directions were determined from the pre-repair groundwater contours as shown in Figure 10. Possible maximum and minimum FES contributory areas were estimated from these analyses. The possibility of extremely permeable coarse granular strata extending well

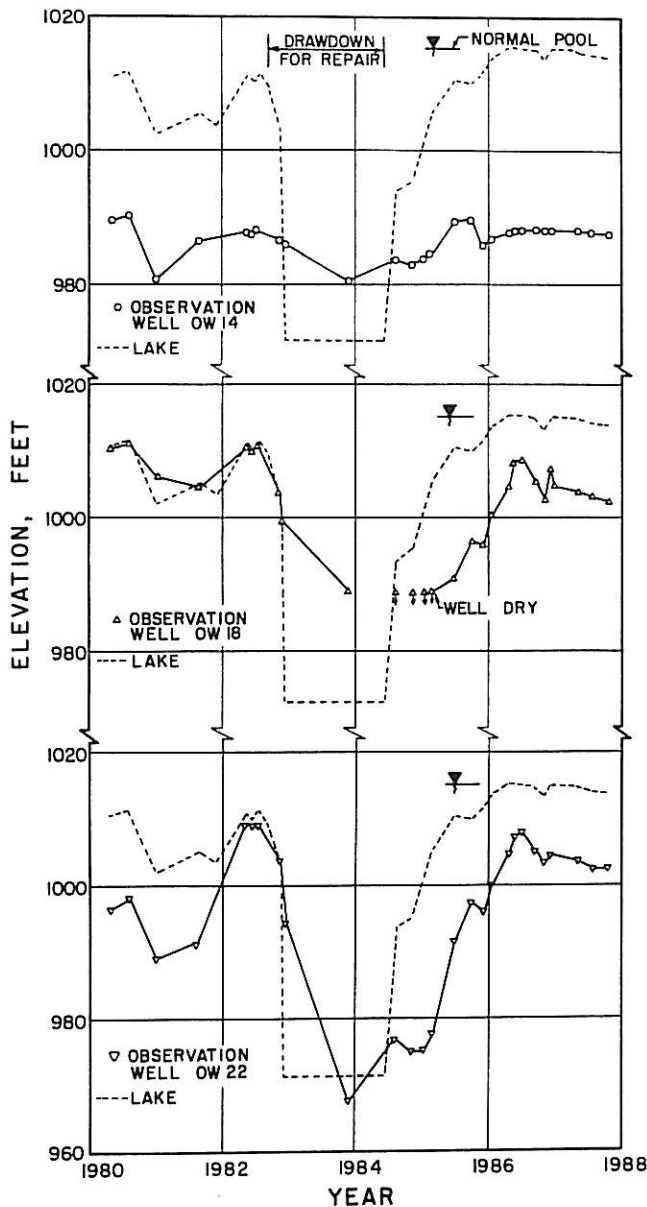
Figure 12. Measured Pre- and Post-Repair Groundwater Levels in Three Observation Wells

In general, the observation well readings were erratic, as would be expected for these conditions. However, some insight to the blanket performance is indicated by the readings in three typical groundwater observation wells, OW-14, OW-18, and OW-22, judged to be responsive to the lake levels before and after the blanketing repair, at locations shown in Figure 10. These readings are plotted in Figure 12. The before and after readings for OW-14 and OW-18 indicate an increased head loss or degree of separation between the lake and groundwater after the repair. The same holds true for OW-22 for lake levels above Elevation 1000.
