## CASE HISTORY

### Bedrock Groundwater Flow Analysis Beneath a Former Industrial Facility

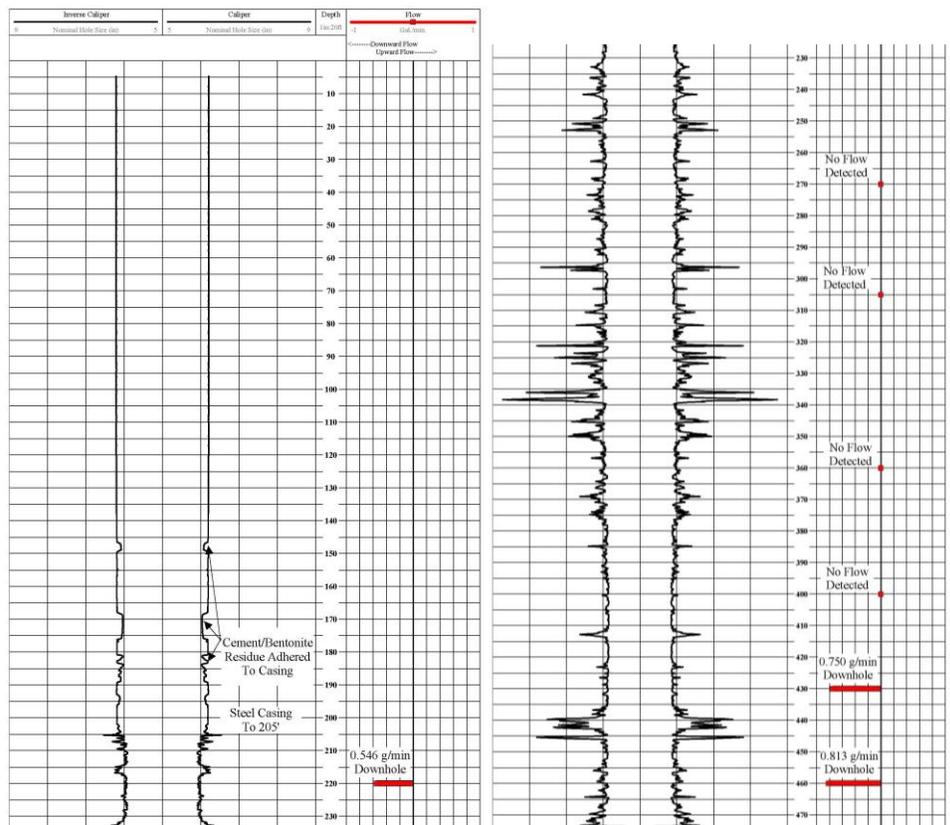
The caliper log (presented with both the original and mirror image to show repeatability) indicates that several fracture zones are present in the bedrock, with the greatest fracturing occurring beneath 300 feet of depth. Video inspection of the hole confirmed the presence of these zones of fracturing/weathering. The flow log indicates that in general, the upper 400 feet of the borehole are under stable flow conditions, and that flow is downward beneath 420 feet, increasing in magnitude towards the bottom of the hole. This is due to an inflow of groundwater from the fractures at that depth interval, which may be transmitting the chlorinated solvent impacts.
