CASE HISTORY

Subsurface Imaging of Slope Failures

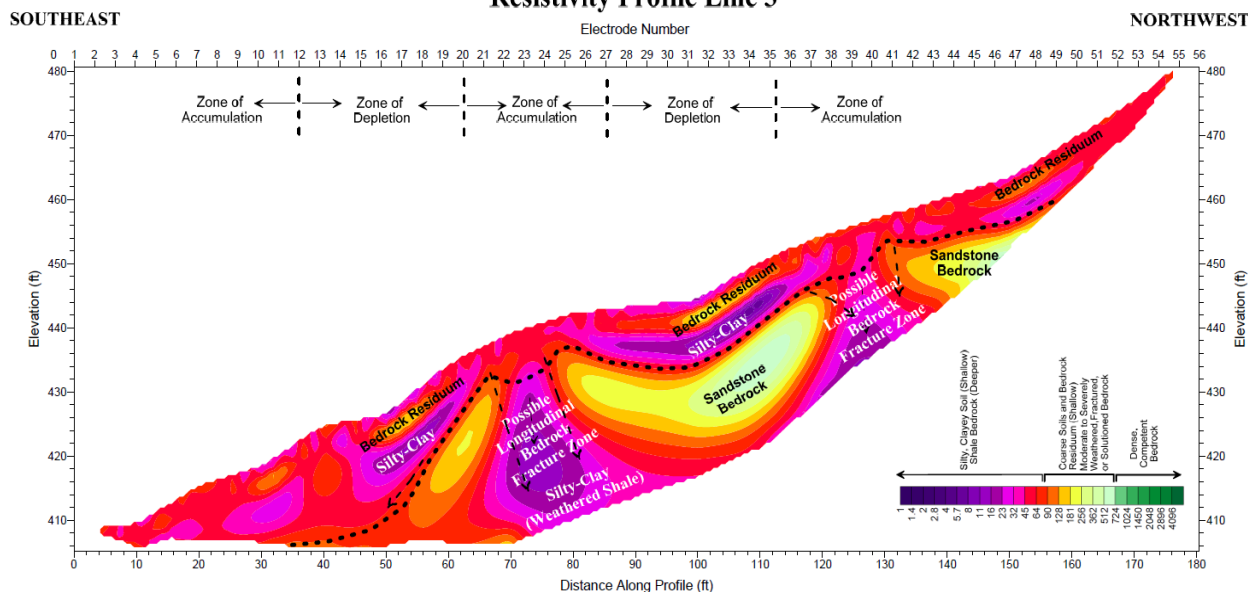
Resistivity Profile Line 3

The geophysical survey was successful in imaging the unique character of the unconsolidated soil materials overlying bedrock beneath the slope. The variation in the orientation of the soil/bedrock layers beneath the slope helps to illustrate key slope failure features: zones of depletion and accumulation that have likely resulted from multiple past slope movements, as well as potential longitudinal fracture zones. The data proved to be extremely valuable in the road-slope stability design phase.
