Ohio River Levee Performance Evaluation under Flood Conditions

Purdue Geotechnical Society Workshop
West Lafayette, Indiana
April 15, 2016

John A. Mundell, P.E., L.P.G.
MUNDELL & ASSOCIATES, INC.

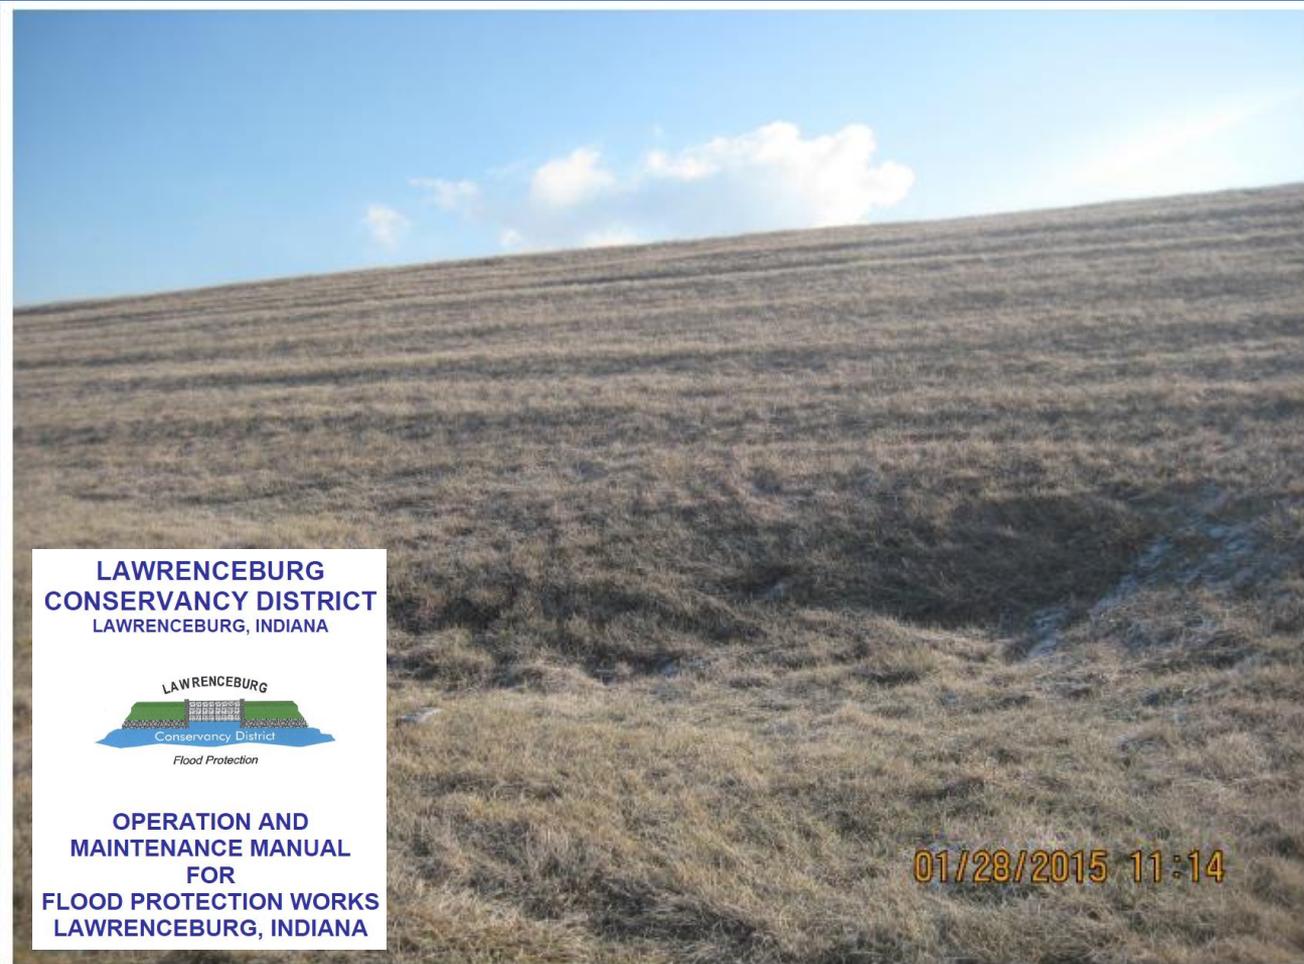
Levee Feature 1 (LF-1): Depression along dry side of levee

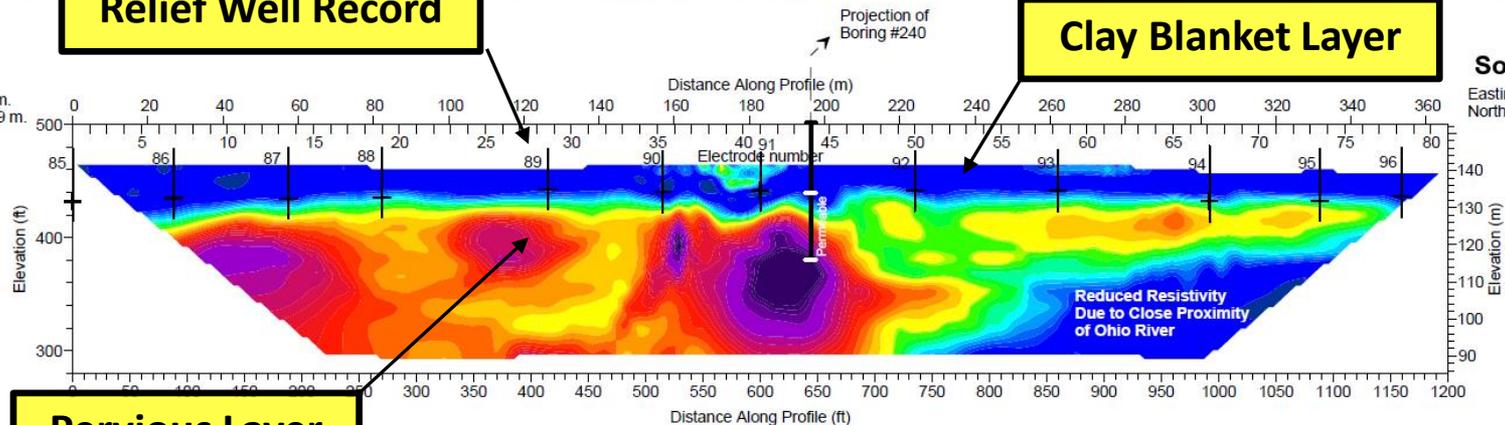
**2D Resistivity Profile with Borings Provides Continuous
Upper Blanket Thickness and high resistivity lower pervious zone**

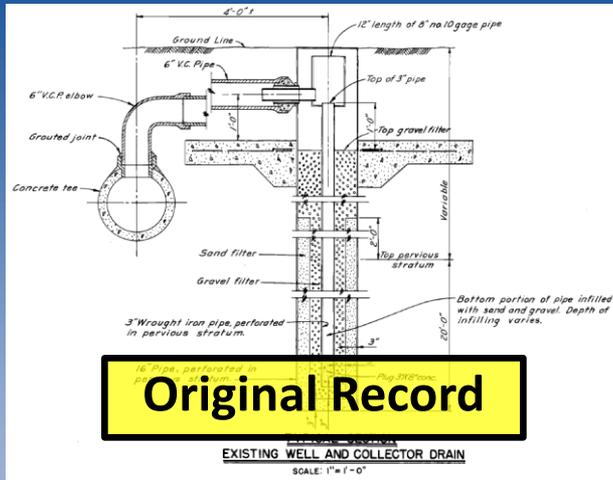
Relief Well - RW15
Existing Condition
July 30, 2014

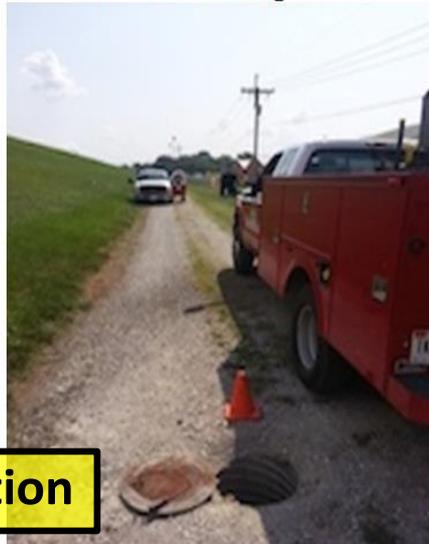
Post Rehabilitation
Relief Well Down Hole Telescoping – RW10
Casing Joint at 20.40'
