Ohio River Levee Performance Evaluation under Flood Conditions

2018 Indiana Academy of Science
Annual Meeting
Indianapolis, Indiana
March 24, 2018

John A. Mundell, P.E., L.P.G., P.G.
MUNDELL & ASSOCIATES, INC.
Consulting Professionals for the Earth and the Environment

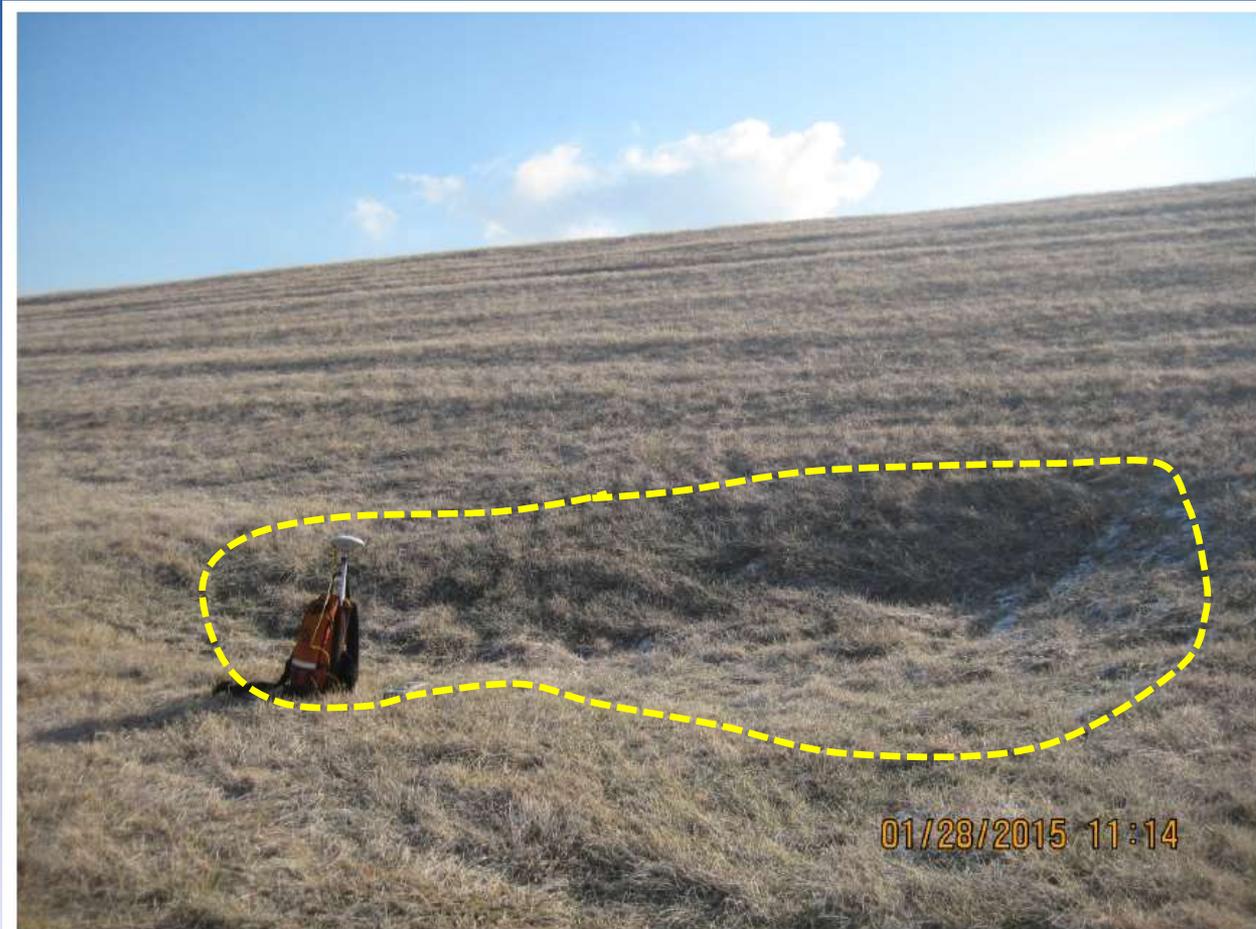
Levee Feature 1 (LF-1): Depression along dry side of levee

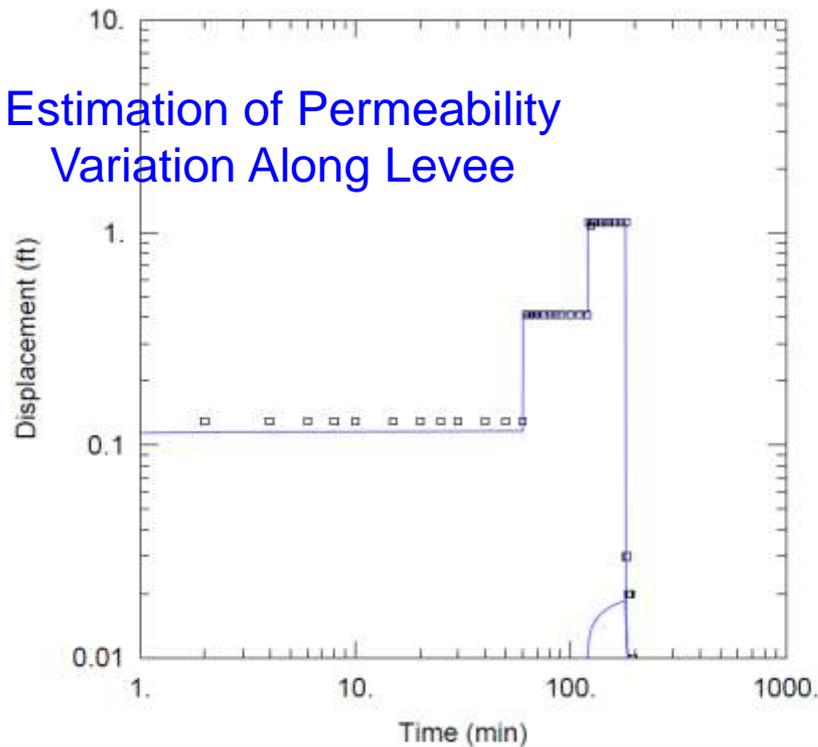
Data Set: T:\...RW-11 POST_Theis (1935) Confined Solution
 Date: 05/14/15 Time: 08:42:15

Company: Mundell & Associates Inc.
 Client: LCD
 Project: M14051
 Test Well: RW-11
 Test Date: 9/16/14

$T = 1480.4 \text{ cm}^2/\text{sec}$
 $S = 0.01646$
 $S_w = 20$
 $C = 0.01522 \text{ min}^2/\text{ft}^5$
 $P = 2.44$
