# Geophysical Examination of Ohio River Levees for Enhanced Flood Performance Evaluation

**GSA 2018  
Indianapolis, Indiana  
November 7, 2018**

**John A. Mundell, P.E., L.P.G., P.G.  
Forrest Kunkel, G.I.T.  
MUNDELL & ASSOCIATES, INC.**

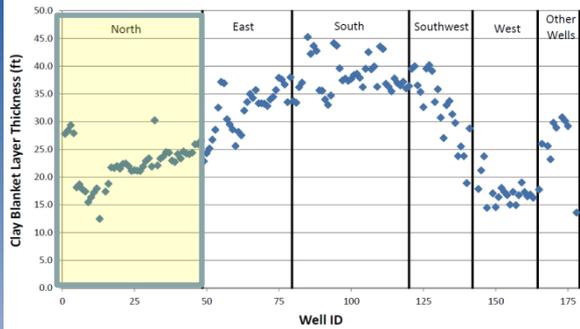
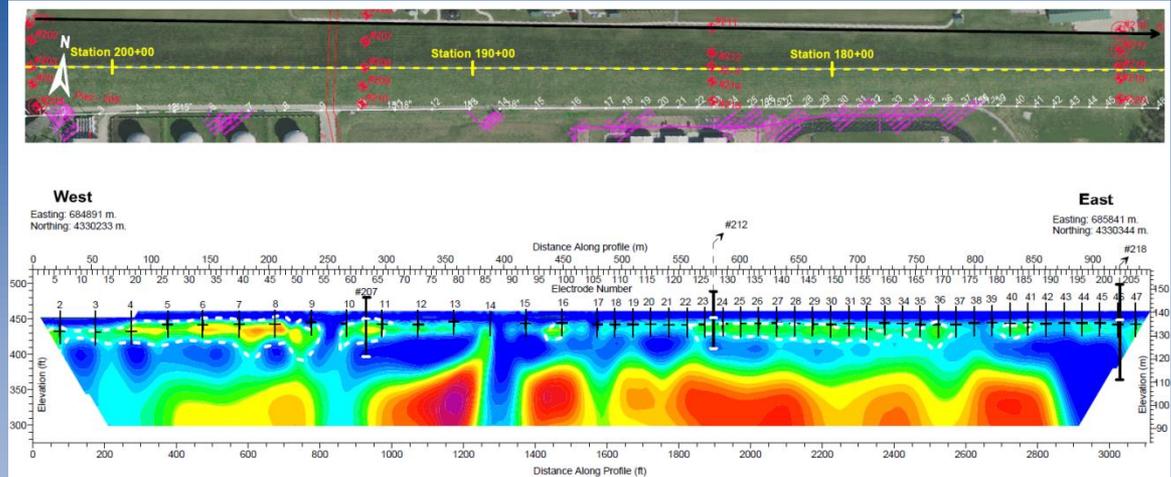
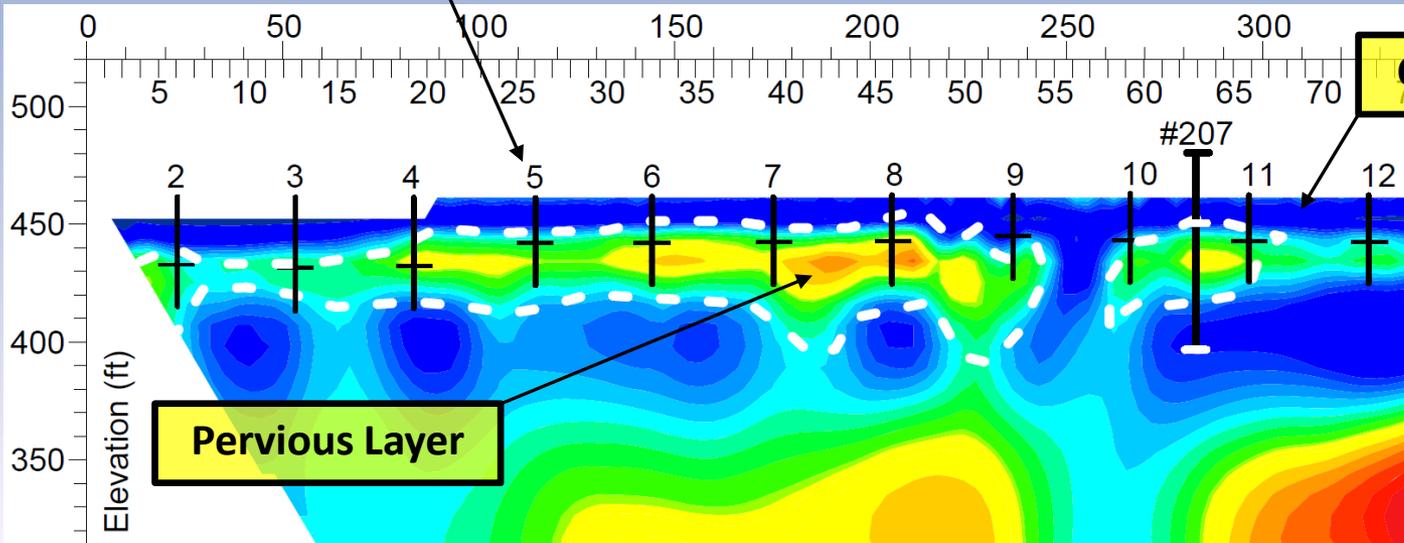
Figure 5B. Clay Blanket Layer Thickness vs. Relief Well Identification Number

- Clay Blanket
- Pervious Layer
- High permeability zones

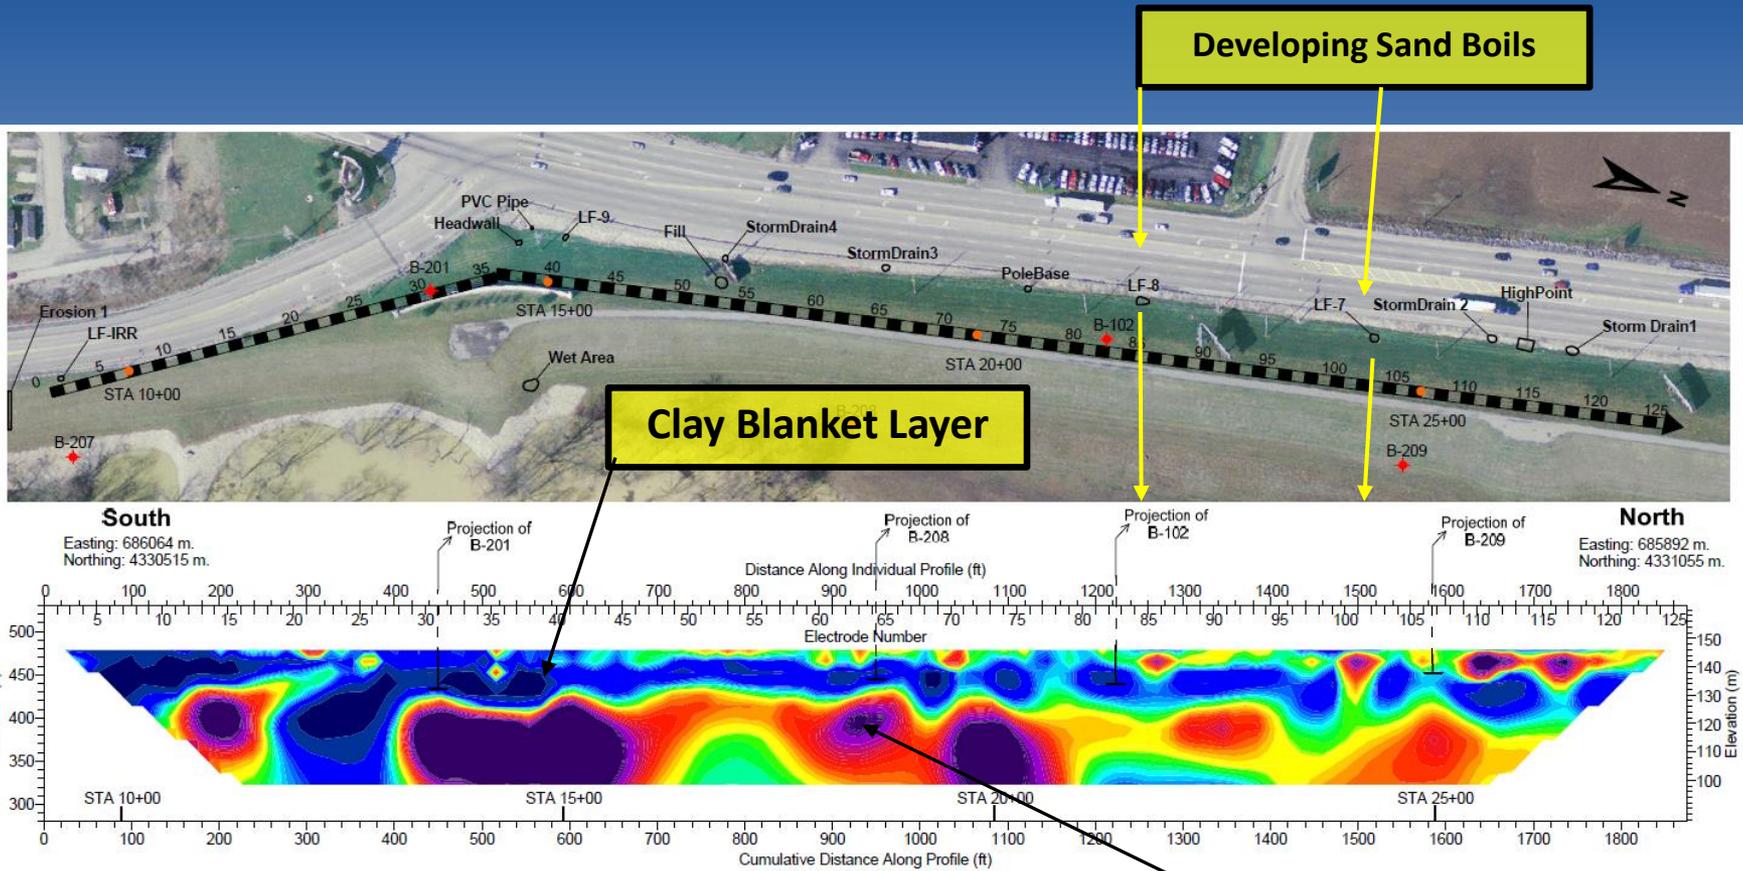
# Resistivity Profile Line GDALE1

**Observations:** Increased shallow granular zones toward the North; some evidence of lack of continuity of the clay blanket layer toward the north; observations of potential developing sand boils near northern end of profile.

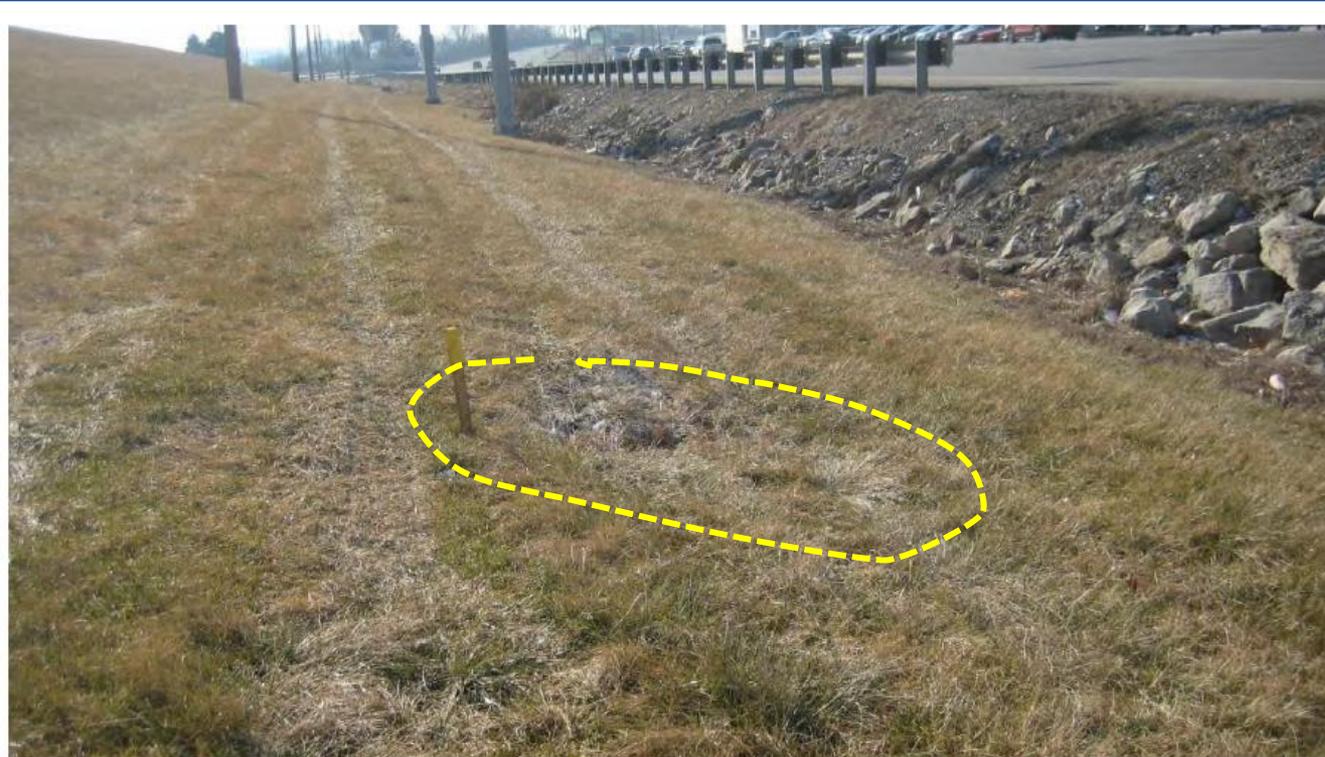
# Resistivity Profile Line GDALE1

**Levee Feature 7 (LF-7):** Surface depression (right of stake) along the dry side of the levee. According to the LCD, this depression is in line with the fiber optic cable.

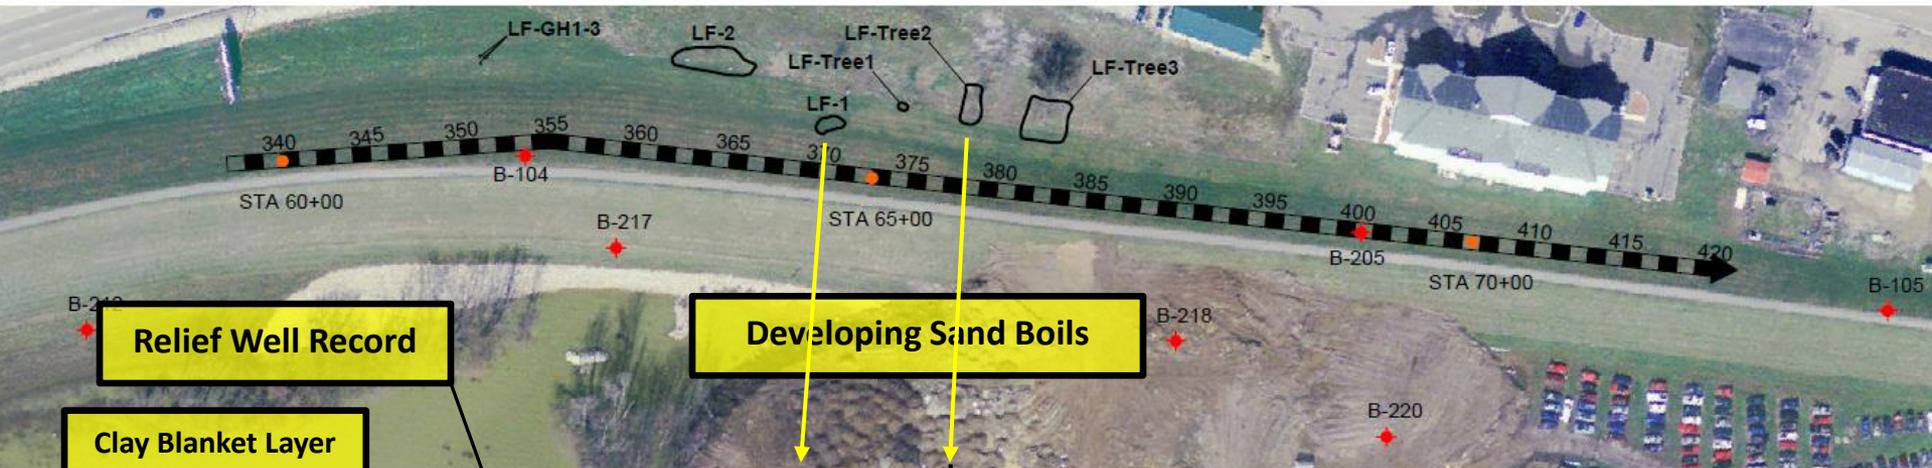
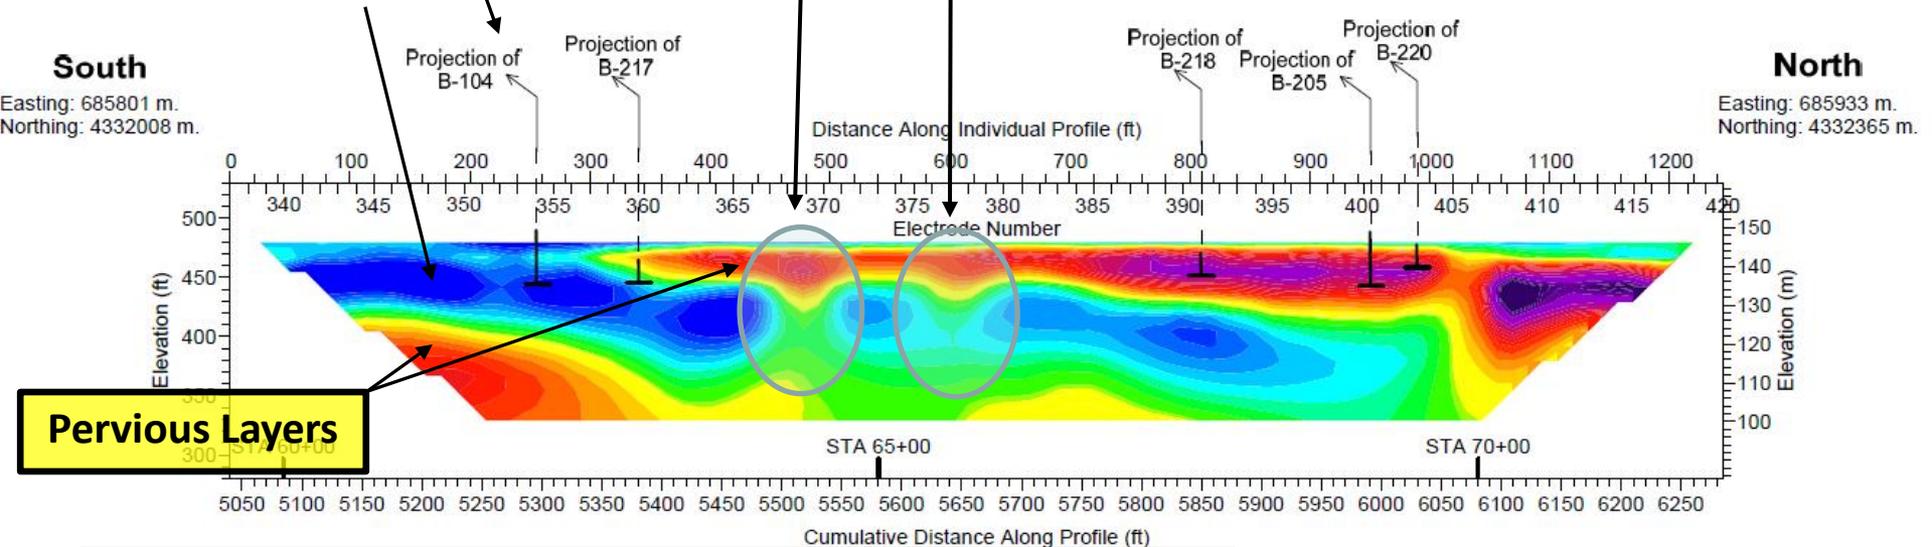
# Resistivity Profile Line GDALE5

**2D Resistivity Profile with Borings Provides Continuous Upper Blanket Thickness and high resistivity lower pervious zone**

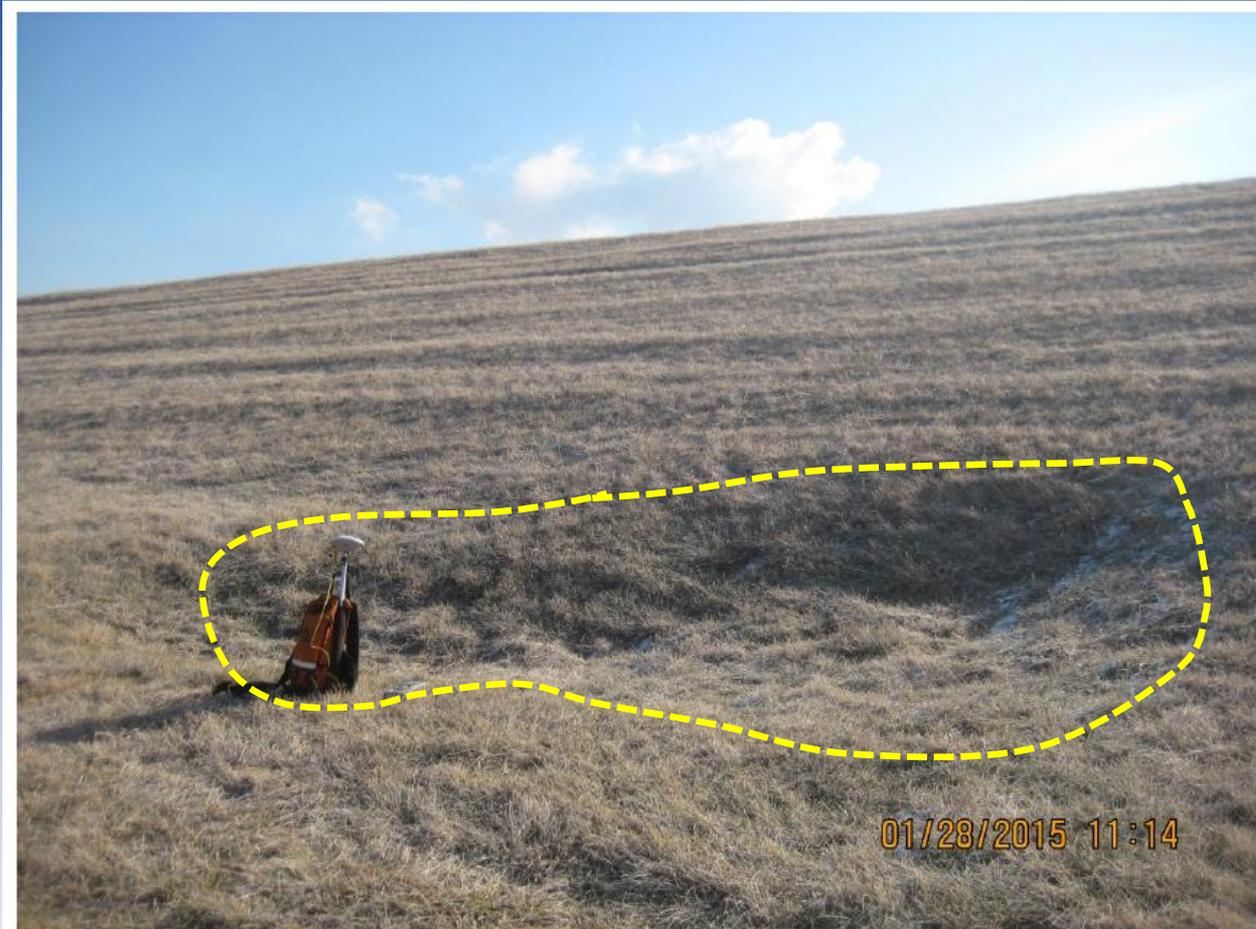
# Resistivity Profile Line GDALE5

Levee Feature 1 (LF-1): Depression along dry side of levee

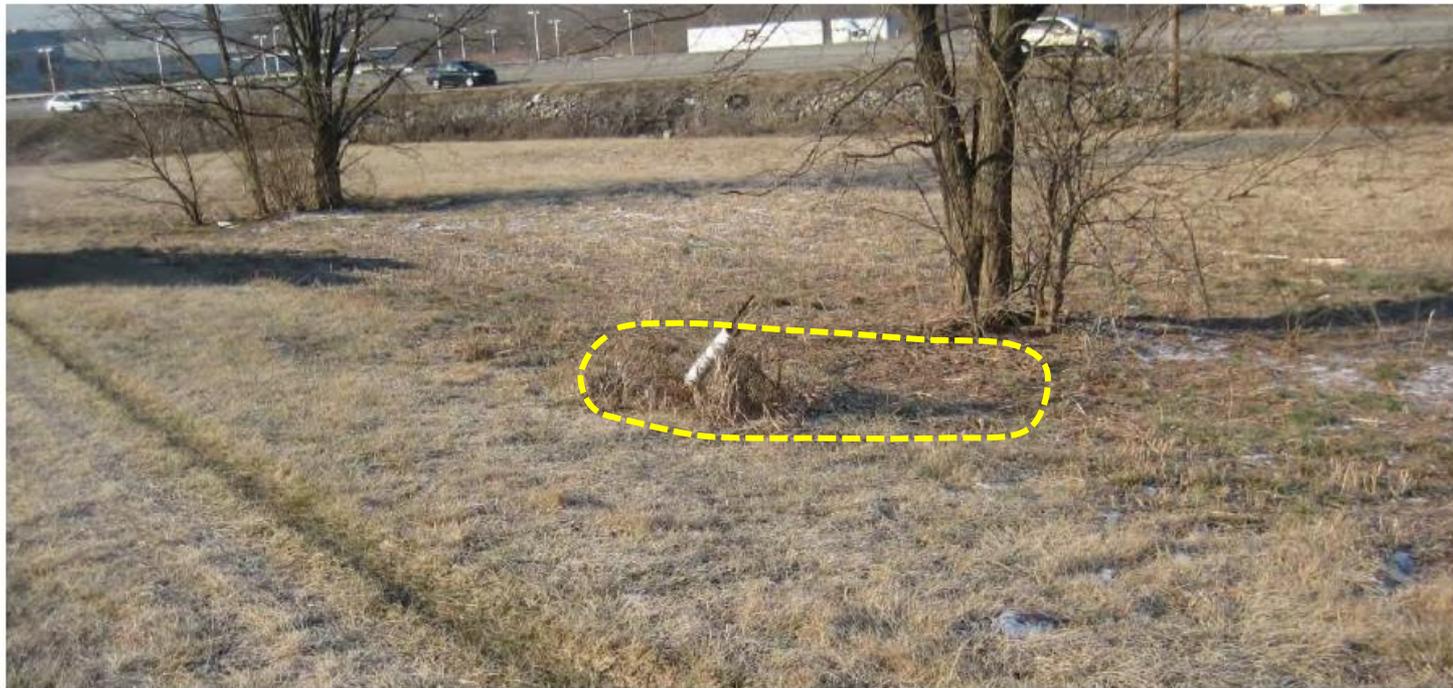
# Resistivity Profile Line GDALE5

**Levee Feature Tree 1 (LF-Tree1):** Surface depression along the dry side of the levee. The depression can be seen where the white pole is protruding from the ground. According to the LCD, the property line is at the turf/cornfield interface.
