CASE HISTORY

Subsurface Imaging of Historic Canal Aqueduct Failure

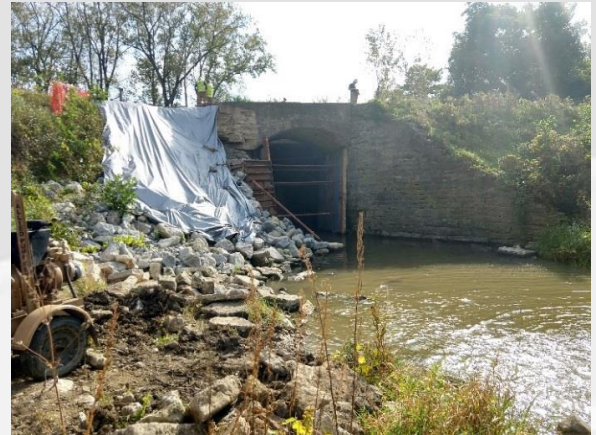
A wing wall failure at the Six Mile Creek Aqueduct on the Miami and Erie Canal in Auglaize County, Ohio prompted concern for the integrity of the remaining structure and required remedial efforts to correct the failure to preserve the historic aqueduct. The nature of the wing wall failure and observed seepage through the aqueduct foundation materials indicated that water may be flowing through voids in the foundation material, potentially resulting in further erosional damage to the remaining aqueduct foundation. The purpose of the study was to assist in evaluating material anomalies, voids, subsidence and/or groundwater in the backfill areas of the abutment and wing walls for enhanced remediation planning.

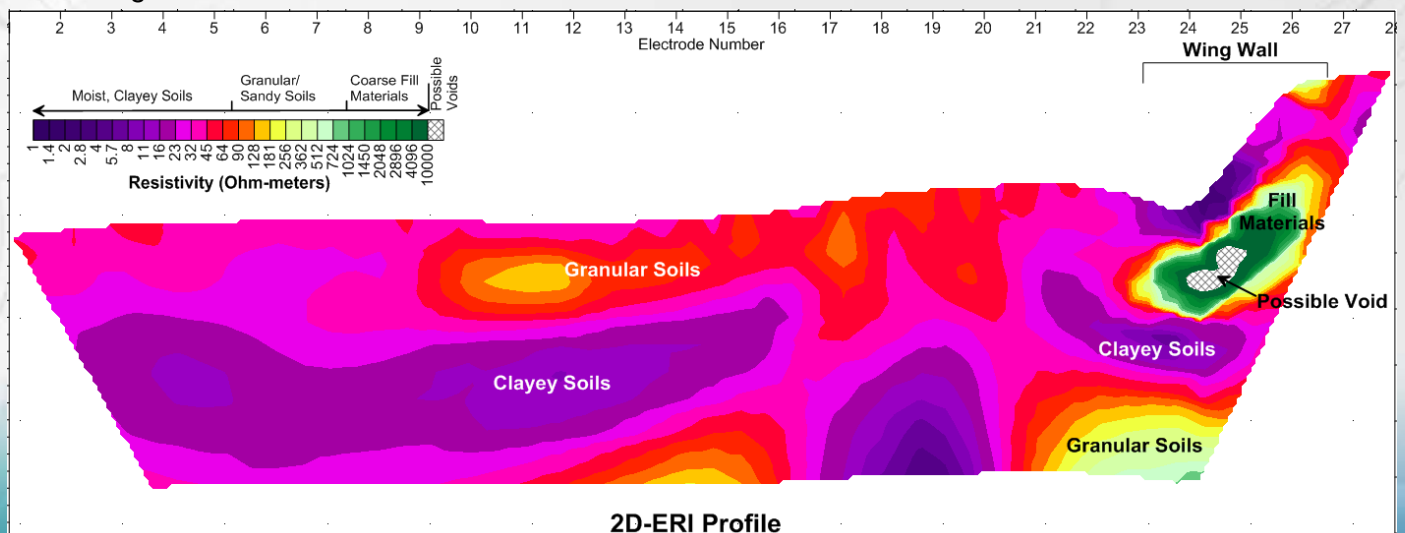
The results of the terrain conductivity and ERI results were consistent with each other and indicated the presence of coarse-grained, granular fill material with potential void spaces within the embankment behind the stone block abutment and wing walls. The GPR survey results also indicated the likely presence of significant void development behind the remaining abutment and wing wall structures. The findings of this study were used to inform remedial efforts, which ultimately led to a successful repair of the Aqueduct's failed wing wall structure.
