CHLORINATED HERBICIDE LEACHING FROM UTILITY POLES AND POTENTIAL IMPACT ON PRIVATE WATER WELLS: FIRST DOCUMENTED CASE FROM INDIANA

Indiana Academy of Science
Annual Meeting
March 24, 2018

Rachel Walker, PhD, L.P.G.
John A. Mundell, P.E., L.P.G.

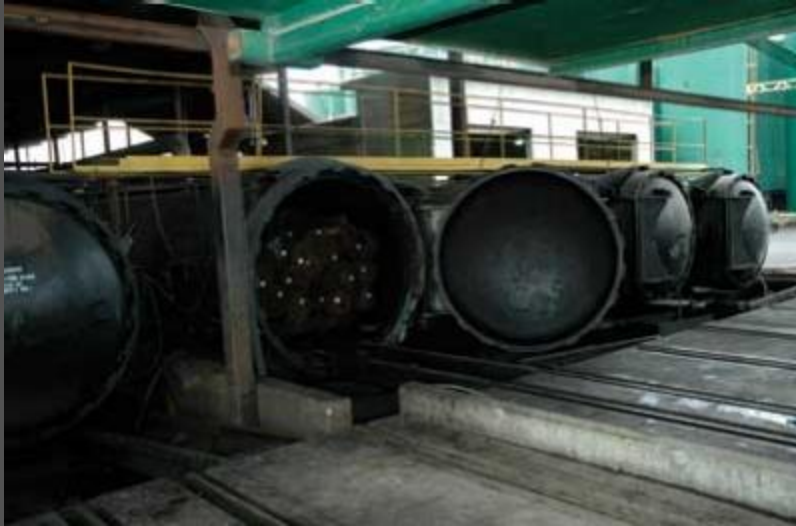
Pentachlorophenol (PCP) wood treatment

Wood is pressure treated in a retort with a solution of PCP suspended in a petroleum carrier oil.

After pressure treatment, wood is subjected to a vacuum to remove excess liquid.

Wood poles are then removed from the retort and stored on a drip pad until dripping has ceased.

Poles are then stored in open yards until used.

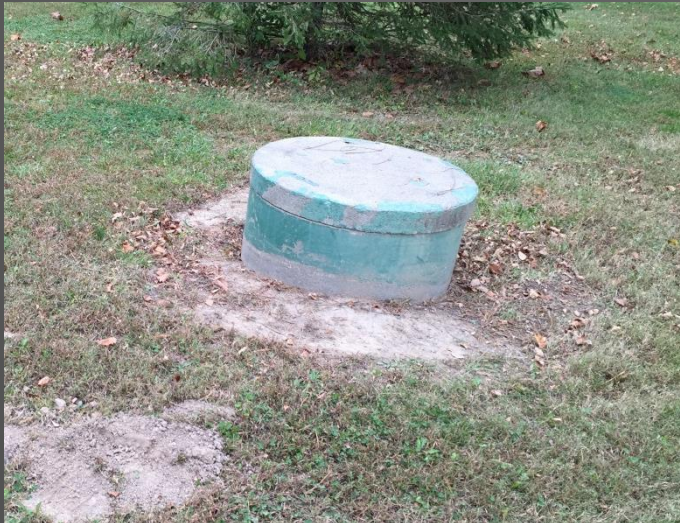
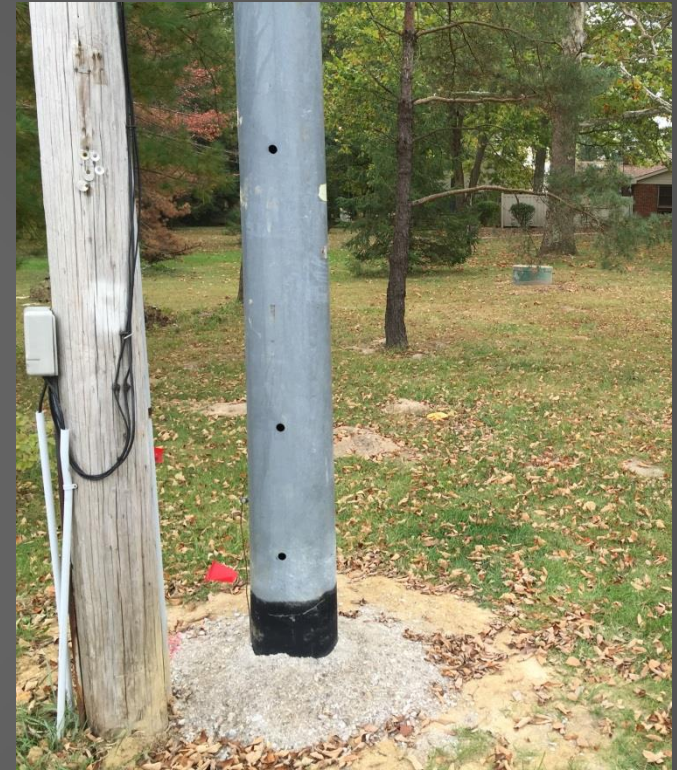
- Well is located 54 feet from the poles, lines up exactly downgradient for groundwater flow.
- Site is flat and water pools across yard in heavy rain.
- The continued presence of PCP after pole removal indicated that PCP had leached from the pole into site soils.

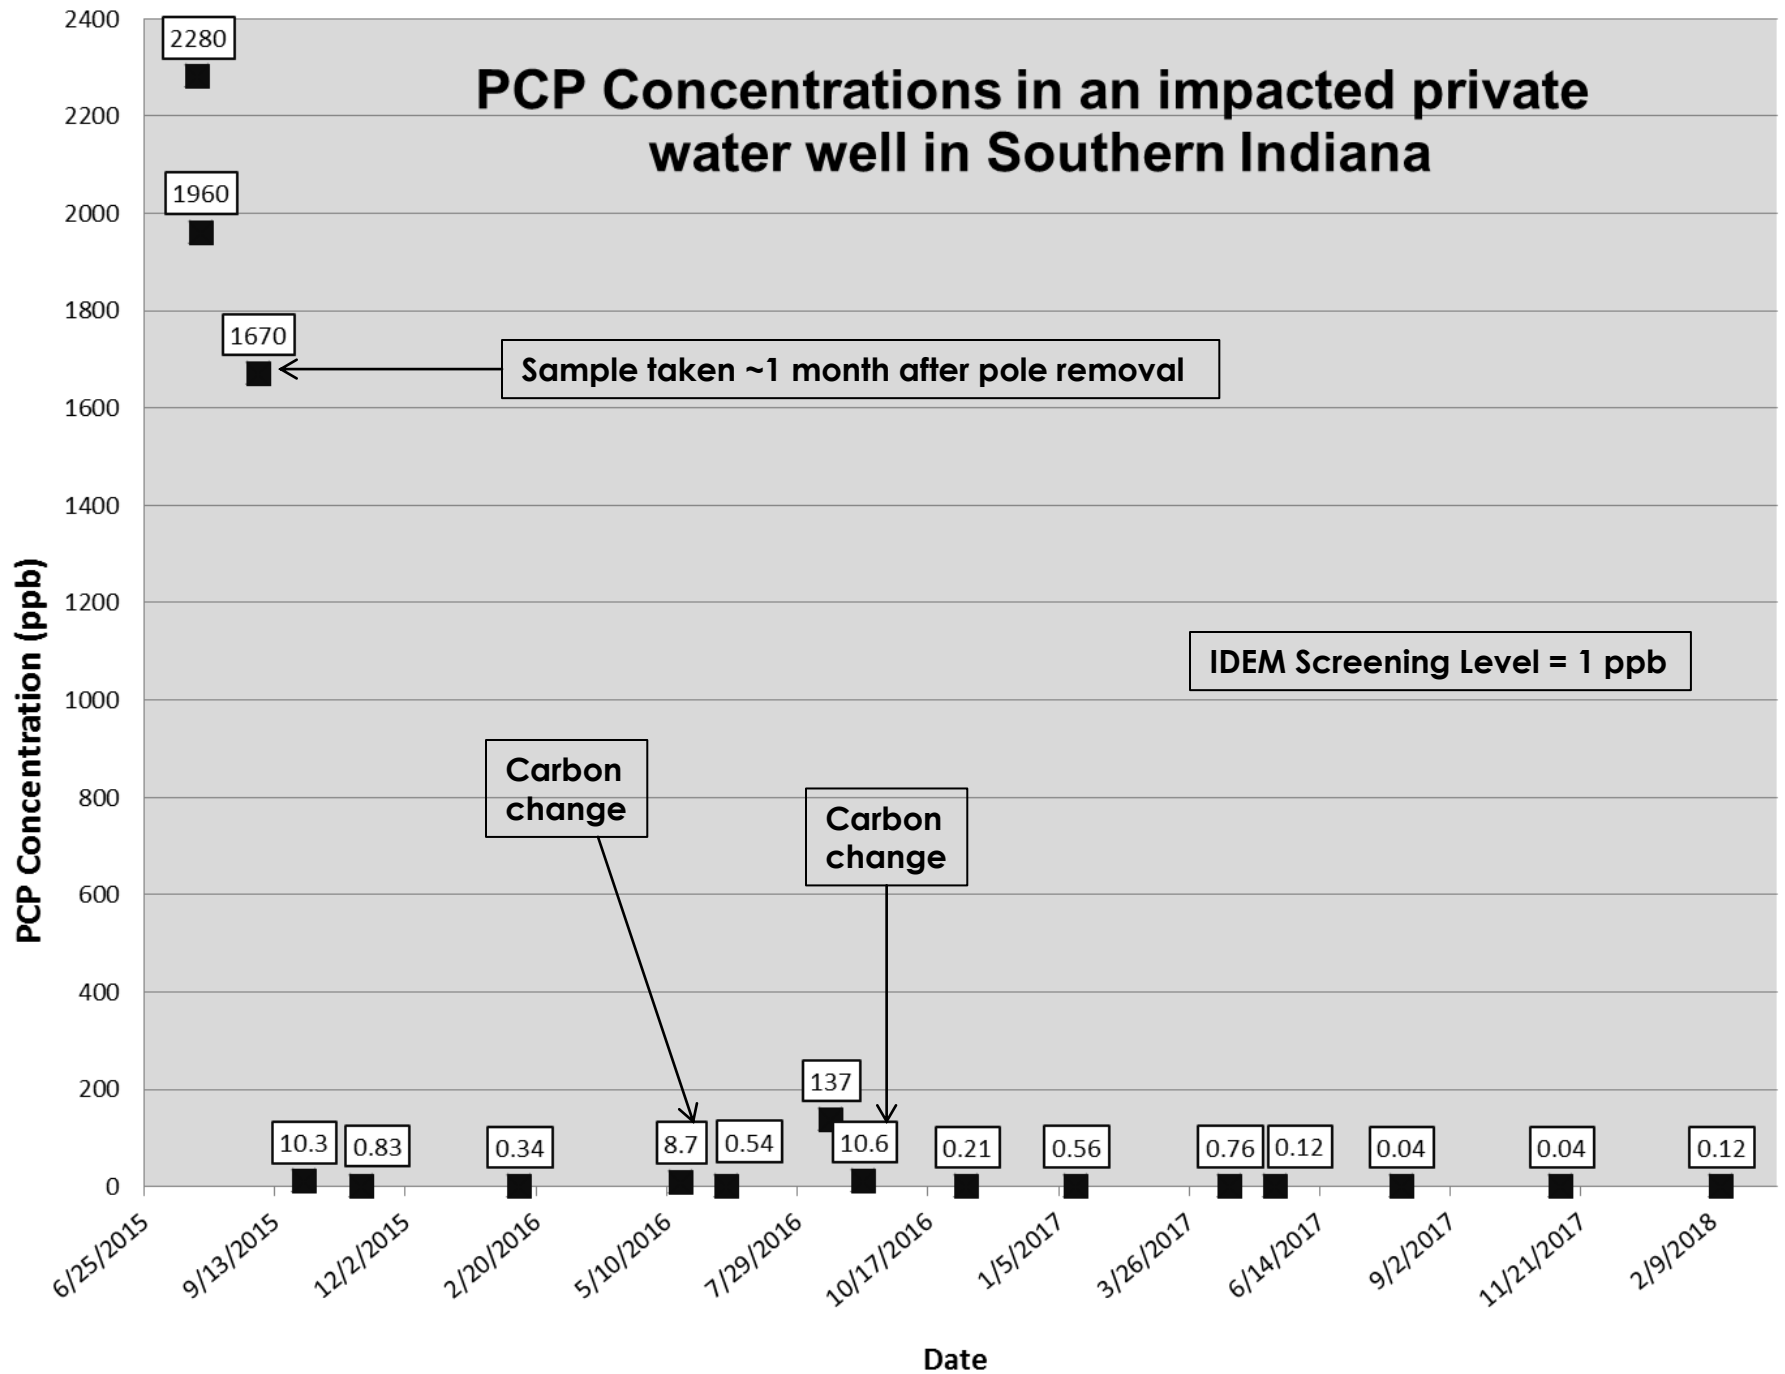
PCP Concentrations in an impacted private water well in Southern Indiana

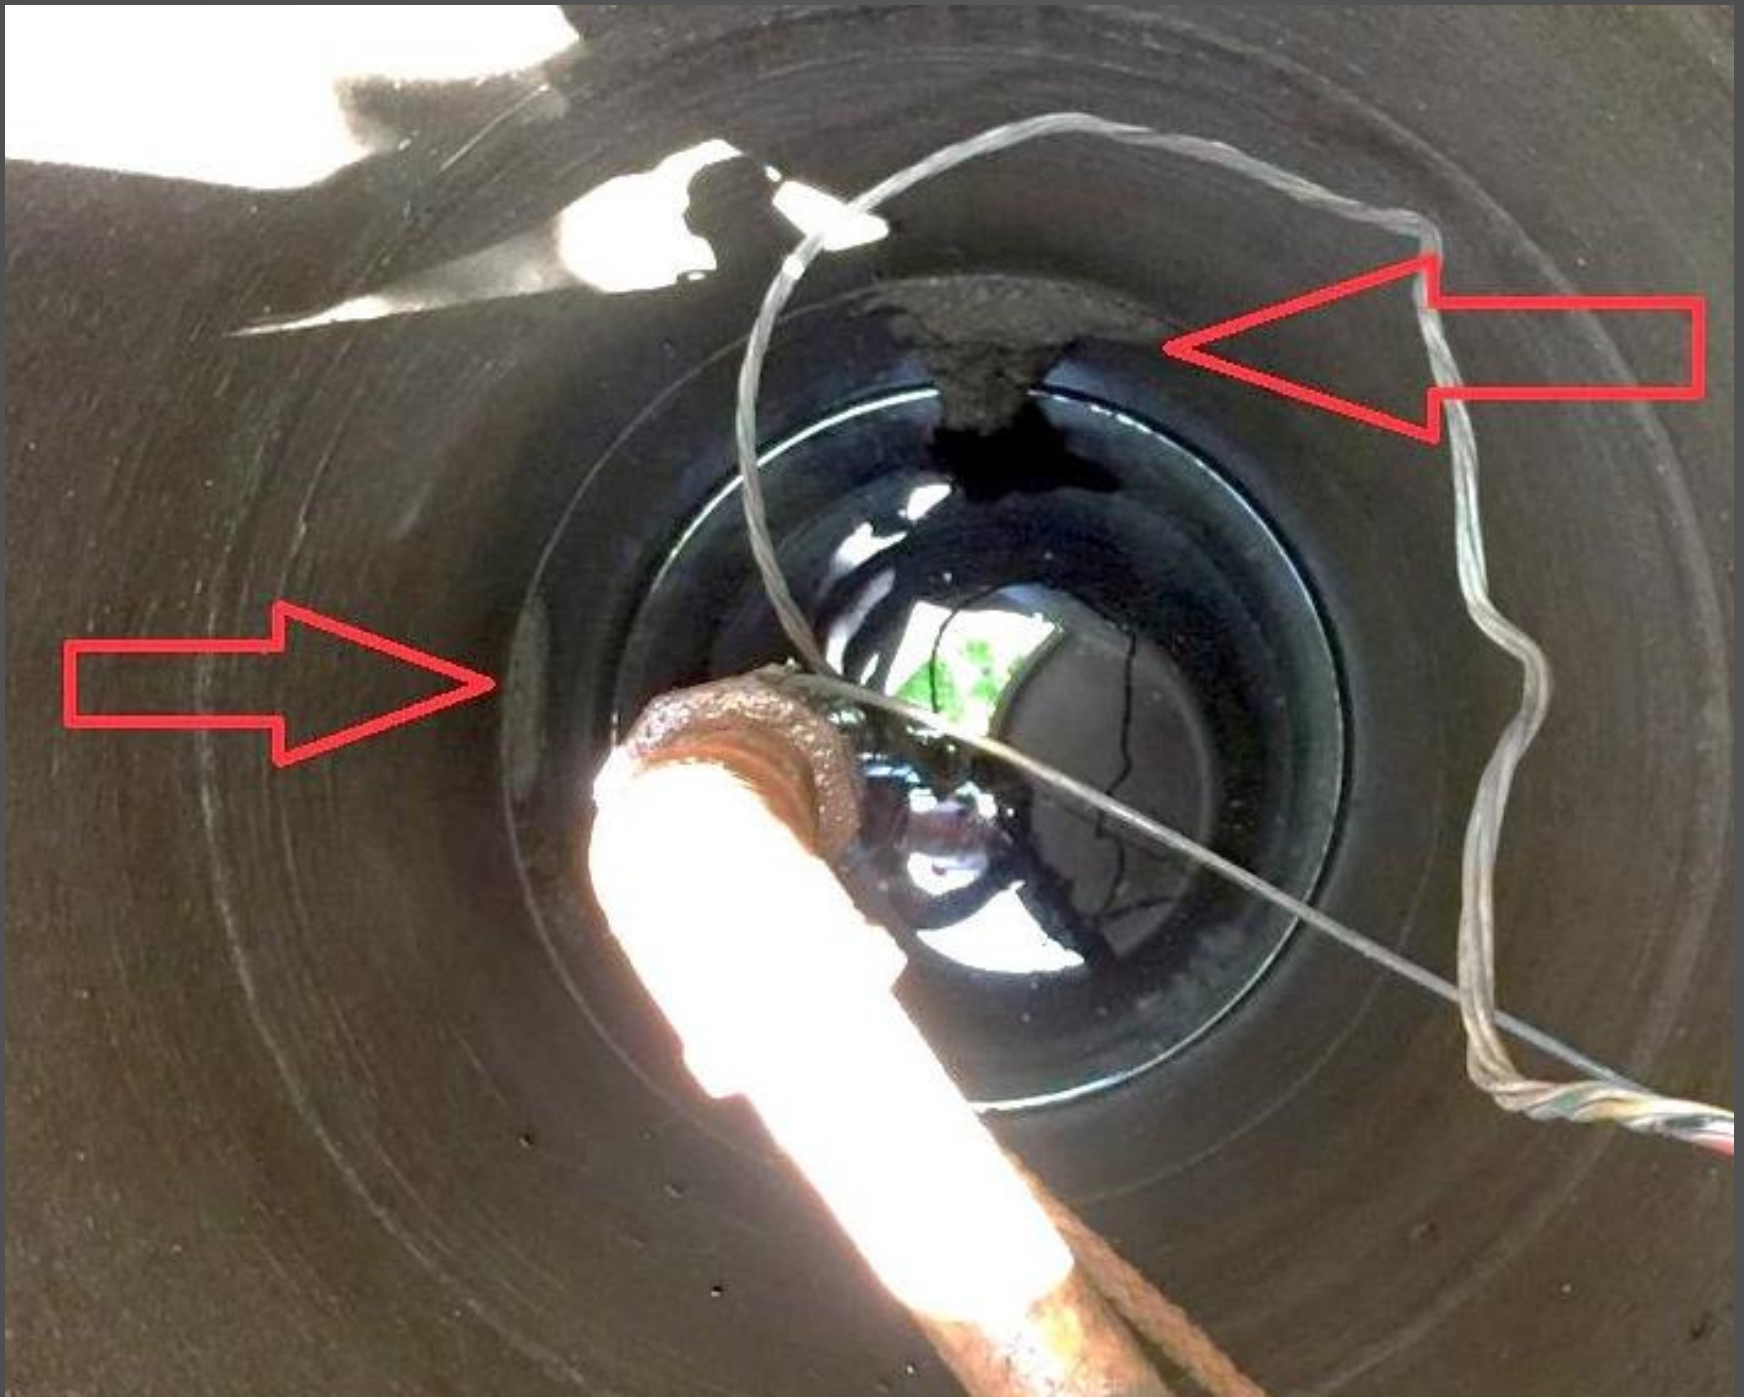
Sediment Infiltration

- Sediment from inside well contained 0.034 mg/kg of PCP.
- Caulking interior of well may stop sediment influx but reduce water supply.
- Site borings indicated that moving well could result in loss of reliable water yield.
- Deep well not an option due to arsenic in bedrock water.
- Ultimately residents chose to stay with existing well and filtration system/monitoring regime.
