# Geophysical Evaluation of Dam Seepage to Support Rehabilitation Efforts

AEG2020 Virtual Conference September 18, 2020

Mundell & Associates, Inc.

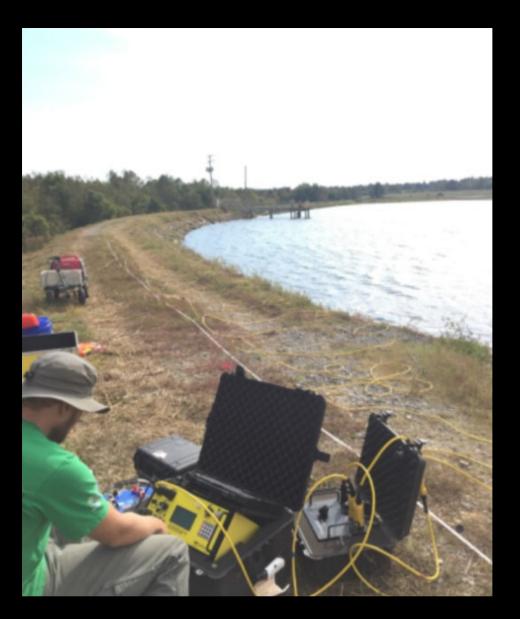
#### 2D-ERI Survey

- Data collected with an AGI SuperSting R8 earth resistivity meter
- Dipole-dipole array of 56
  electrodes at a spacing of 3 ft
  along one long profile line of
  about 1100 ft in length along
  the crest of the dam.
- Data downloaded and inversemodeled using the software Advanced EarthImager2D

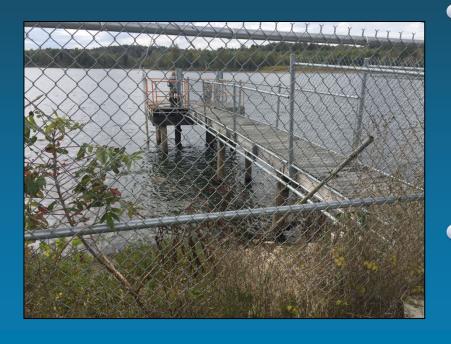
- Some evidence of remaining seepage to the northwest and southeast of the water intake structure where erosion washout is currently observed.
- Geophysical surveys led to understanding of potential seepage pathways and selection of remedial alternative.
