**Second
International Conference
on
Case Histories in
Geotechnical Engineering**

Excessive Seepage Losses at Westwood Lake Dam

SYNOPSIS: Excessive seepage losses at Westwood Lake Dam in east-central Indiana were apparent in 1974 during first filling of the lake when seepage areas developed downstream of the dam and abutments. Several remedial studies were performed which included additional test borings, field and laboratory tests, installation of observation wells, and a review of the site geology and hydrology. Data and observations from these studies were used to develop semi-quantitative assessments of seepage loss rates as related to lake levels. These analyses served as a basis for design of a major repair which consisted of blanketing a significant portion of the lake bottom with on-site, low-plasticity clays and clayey silts. The blanketing was completed in 1984 and post-repair filling required about two years. Subsequent monitoring and observations indicate that the lake level is holding at or within 1.5 ft of the original design normal pool.

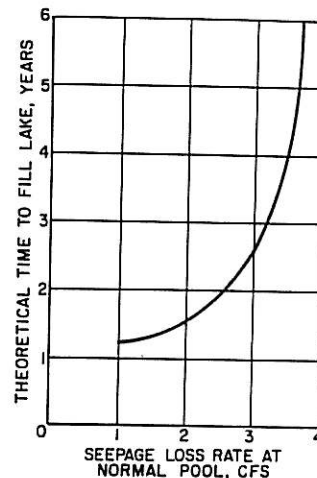
Figure 5. Theoretical Lake Filling Times

An average annual rainfall of 39 in. and an annual lake evaporation of 33 in. are estimated for this site. Several hydrologic analyses of the Westwood Lake watershed were performed based on more detailed seasonal runoff data. Among these was a determination of the theoretical time to fill the lake versus seepage loss rates at the normal pool elevation based on water balance calculations, shown in Figure 5. From this figure, it can be seen that for a total seepage loss rate on the order of 4.0 cfs, the lake will not fill. For the major blanketing repair, it was decided to use a maximum seepage loss rate of 2.0 cfs as a design criterion.

This TLS rate is consistent with Figure 5, in which the lake theoretically would not fill at a seepage loss rate of 4.0 cfs and the observation that the lake did not fill after the original construction (prior to the repair). To achieve a maximum normal pool TLS rate of 2.0 cfs (determined to be acceptable from Figure 5), it was decided to attempt to reduce the normal pool FES rate from 2.8 to 0.8 cfs, taken as a blanketing repair criterion.

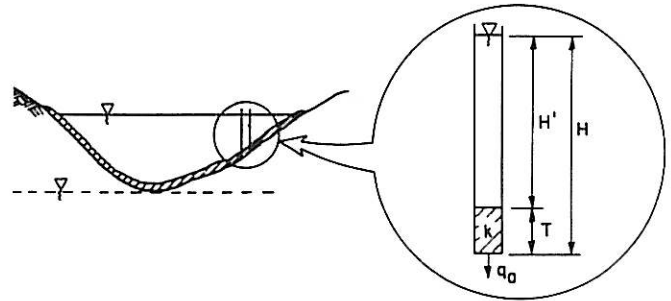
Figure 8. Idealized Seepage Model for Blanket

The blanket thickness was determined using the idealized model shown in Figure 8 and the ensuing theoretical Equation (1) derived from Darcy's Law. This model assumes complete head loss through the blanket and is generally conservative for most locations in the lake area as compared to a more comprehensive analysis that assumes head loss through the blanket and underlying natural soils.

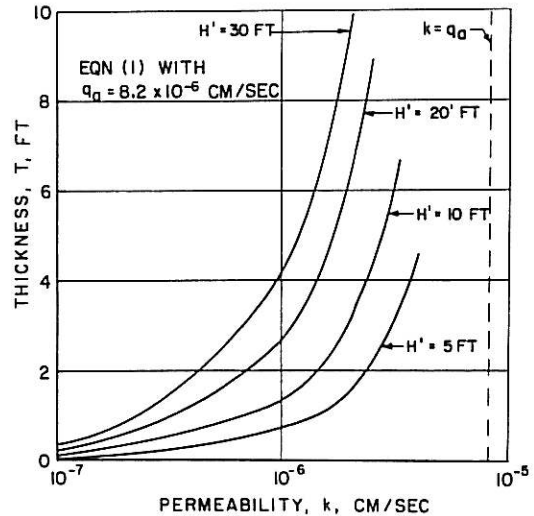
Figure 9. Blanket Thickness vs. Permeability

The value for q_a was determined by dividing the allowable normal pool FES seepage criterion of 0.8 cfs, as established in the preceding section, by the estimated contributory area to the FES. Design relationships between the parameters in this equation are shown in Figure 9 illustrating the sensitivity to the design k-value. It can be seen that if the field k-value is on the order of 10^{-7} cm/sec, then the blanket thicknesses based on $k=1 \times 10^{-6}$ cm/sec are very conservative. On the other hand, if k

approaches 10^{-5} cm/sec, the blanket is pervious and would serve no useful purpose.

Field permeability testing of natural exposed soils around the lake perimeter and results of test borings within the lake area were used to delineate areas where natural clays were present at the lake bottom. The design blanket thicknesses ranged from two ft (determined to be a practical minimum) to four ft in deeper lake areas. The blanketing fill was placed and compacted in lifts to 95 percent of the Standard Proctor value at moisture contents above two percent below the optimum moisture. Compaction near or above the optimum moisture level is important to achieve a high degree of imperviousness for fine-grained soils (Mundell and Bailey, 1985).
