Ohio River Levee Performance Evaluation under Flood Conditions

2018 Indiana Academy of Science
Annual Meeting
Indianapolis, Indiana
March 24, 2018

John A. Mundell, P.E., L.P.G., P.G.
MUNDELL & ASSOCIATES, INC.
Consulting Professionals for the Earth and the Environment

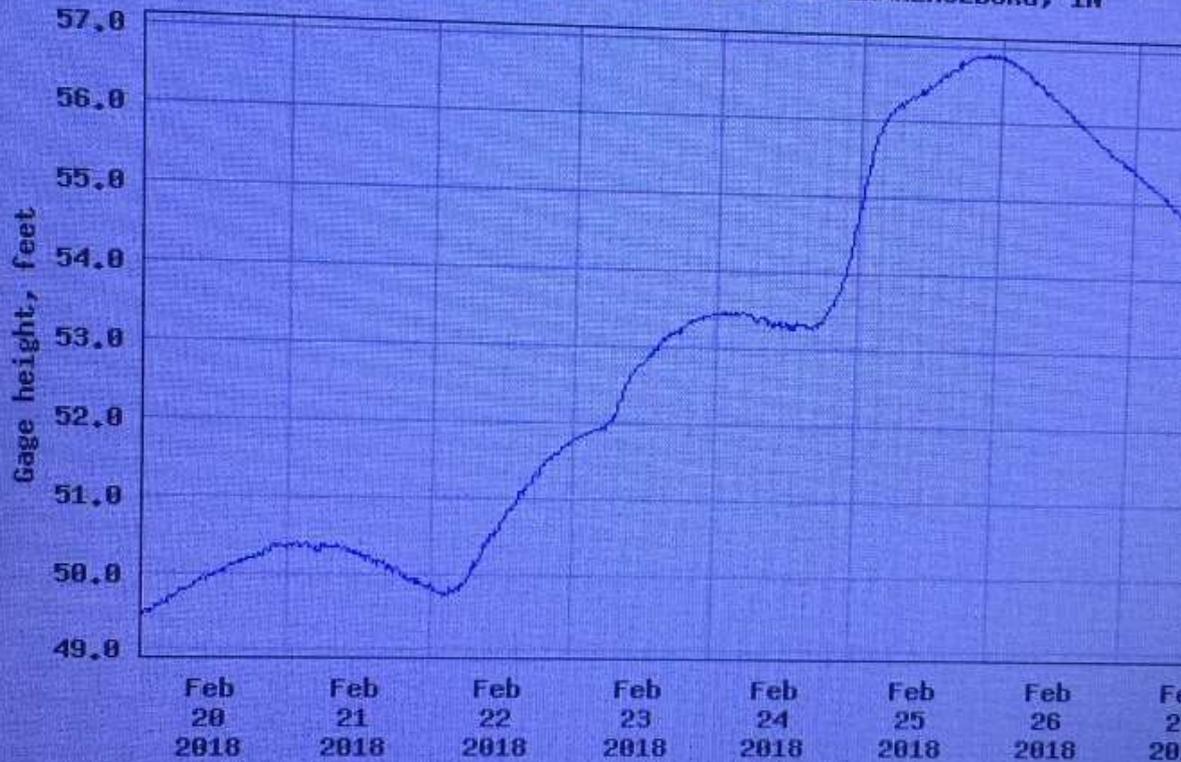
USGS 03276650 TANNERS CREEK AT LAWRENCEBURG, IN

RIVER LEVEL MONITORING

Most recent instantaneous value: 54.62 02-27-2018 12:00 EST

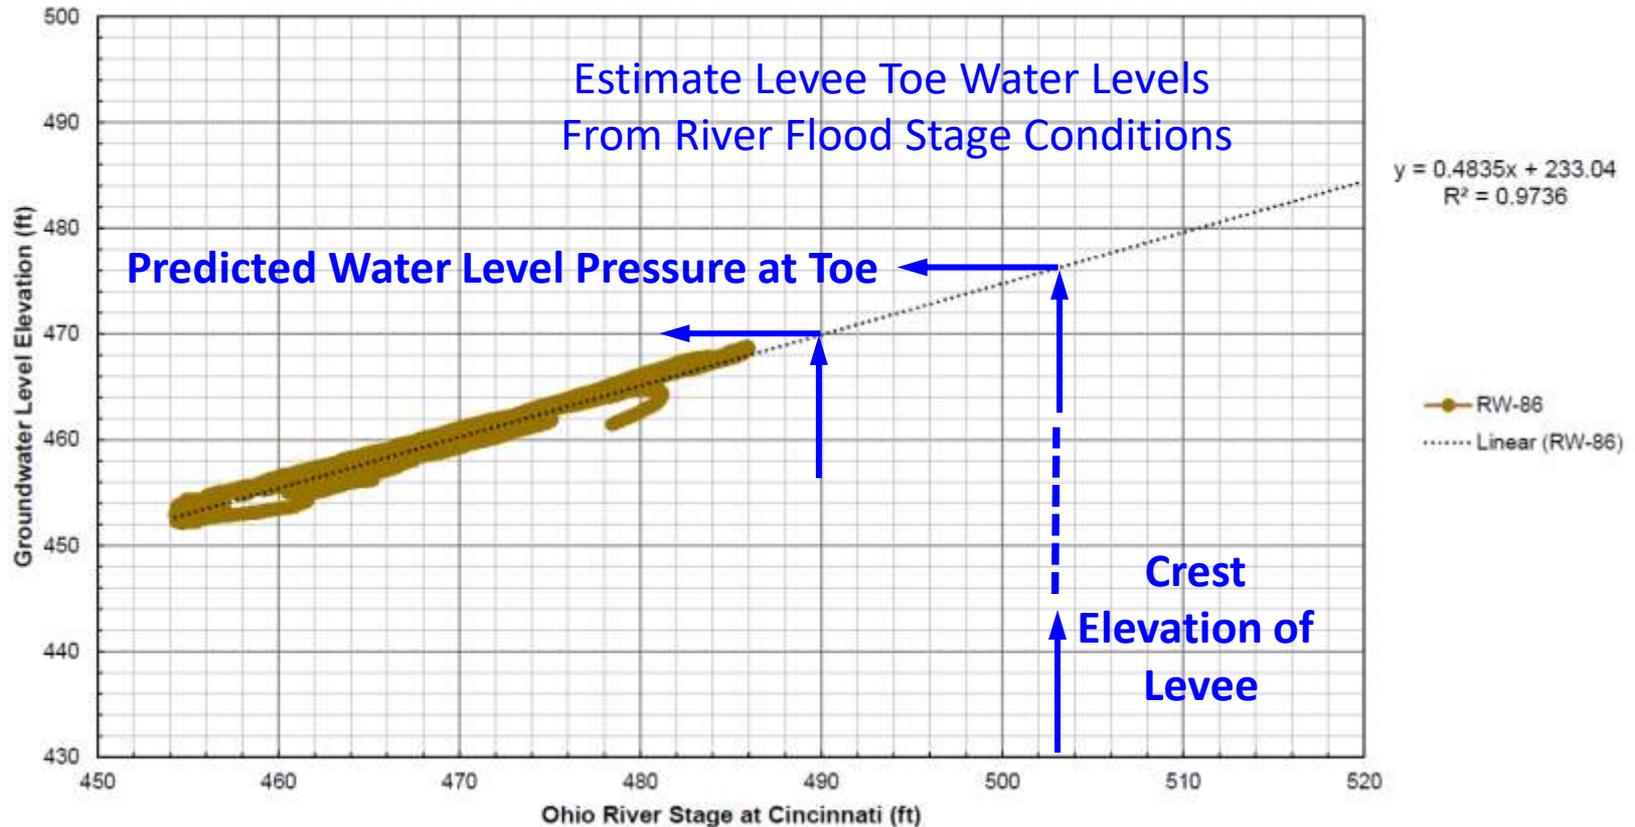
Figure X. River Stage vs. Groundwater Elevation in RW-86

Correlate Water Level to River Levels
