# Geophysical Examination of Ohio River Levees for Enhanced Flood Performance Evaluation

**GSA 2018  
Indianapolis, Indiana  
November 7, 2018**

**John A. Mundell, P.E., L.P.G., P.G.  
Forrest Kunkel, G.I.T.  
MUNDELL & ASSOCIATES, INC.**

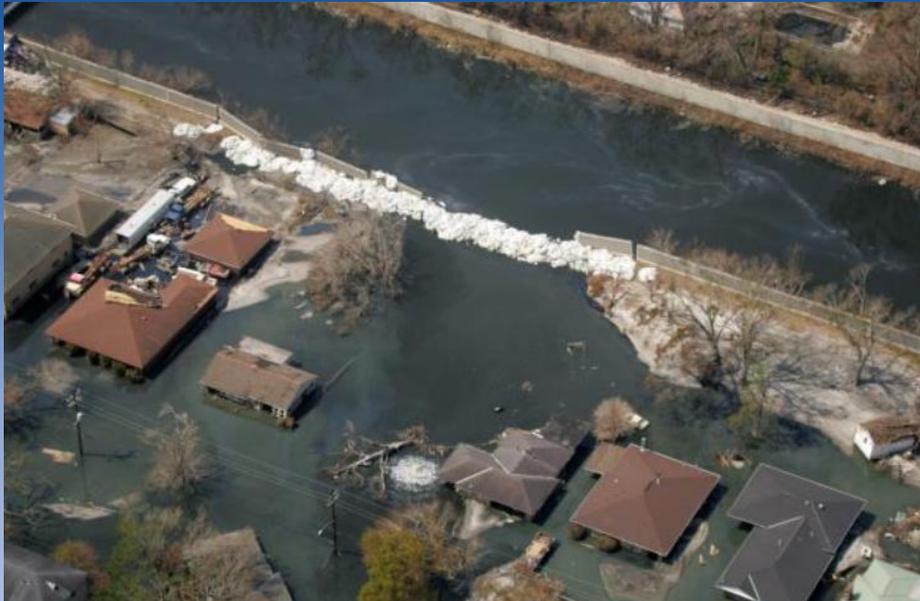
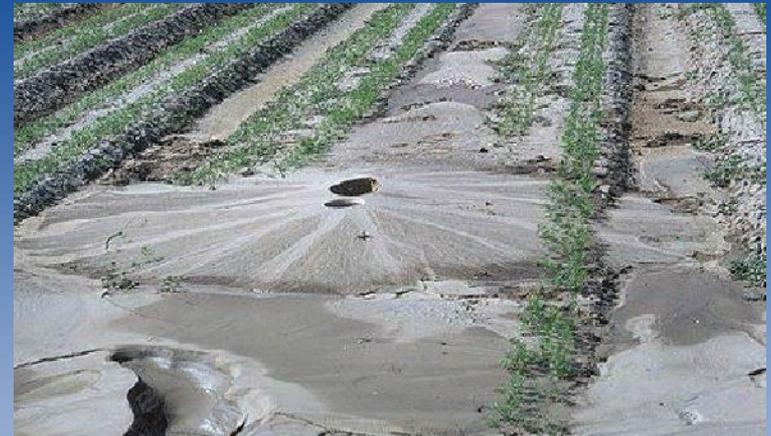
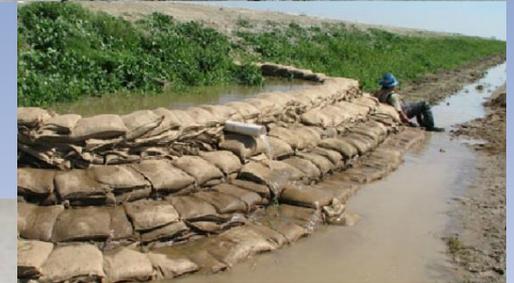
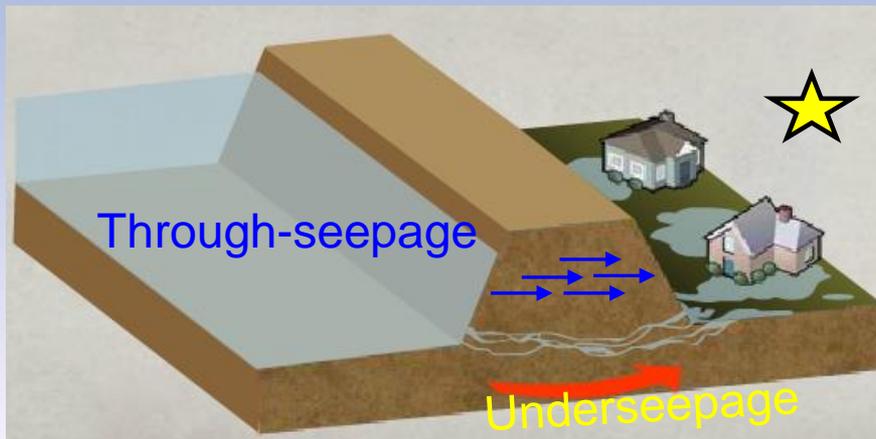
## SEEPAGE

Seepage occurs when, over time, water begins to seep under or through a levee, creating weak spots in its structure. The first signs are puddles of standing water on the inboard side of the levee. Sand boils, bubbling springs at the base of the levee, also begin to form, causing the soil to become unstable, and the levee structure to be compromised. This can result in a total collapse of the levee.

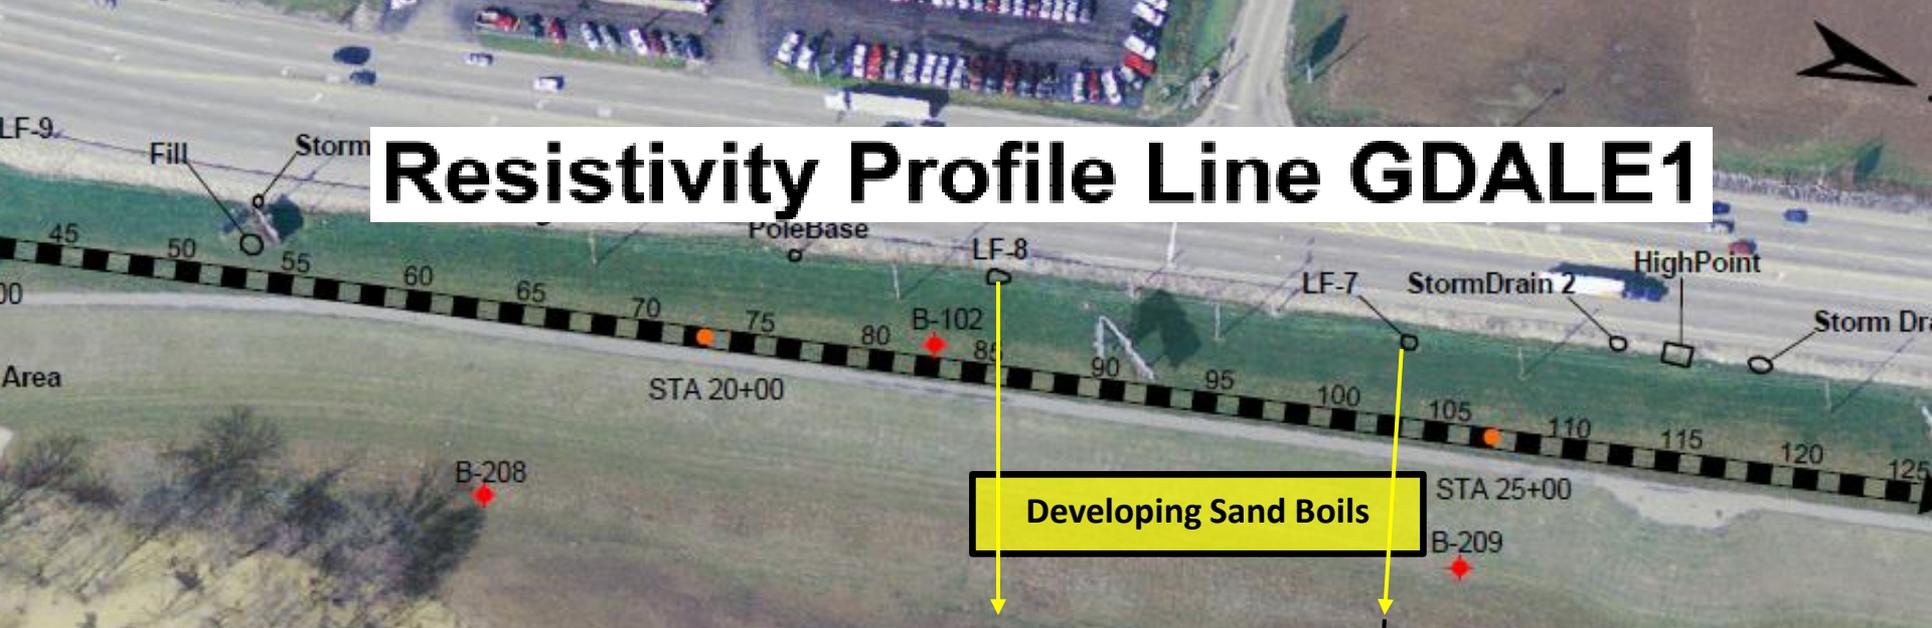
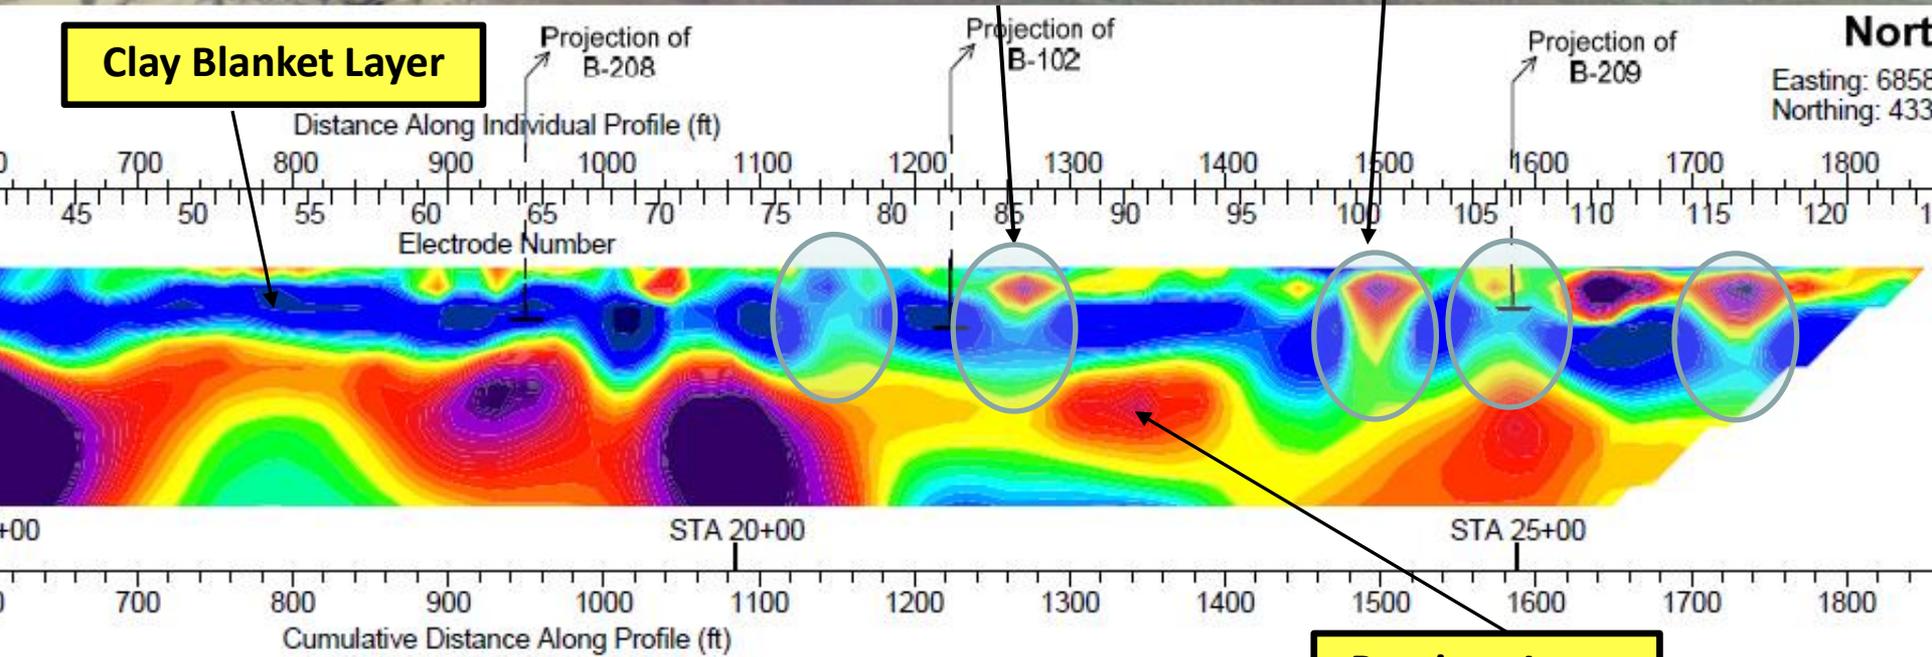
# Resistivity Profile Line GDALE1

North  
Easting: 6858  
Northing: 433
