## ***CASE HISTORY***

### **Analysis of Groundwater Flow Conditions in Limestone Bedrock**

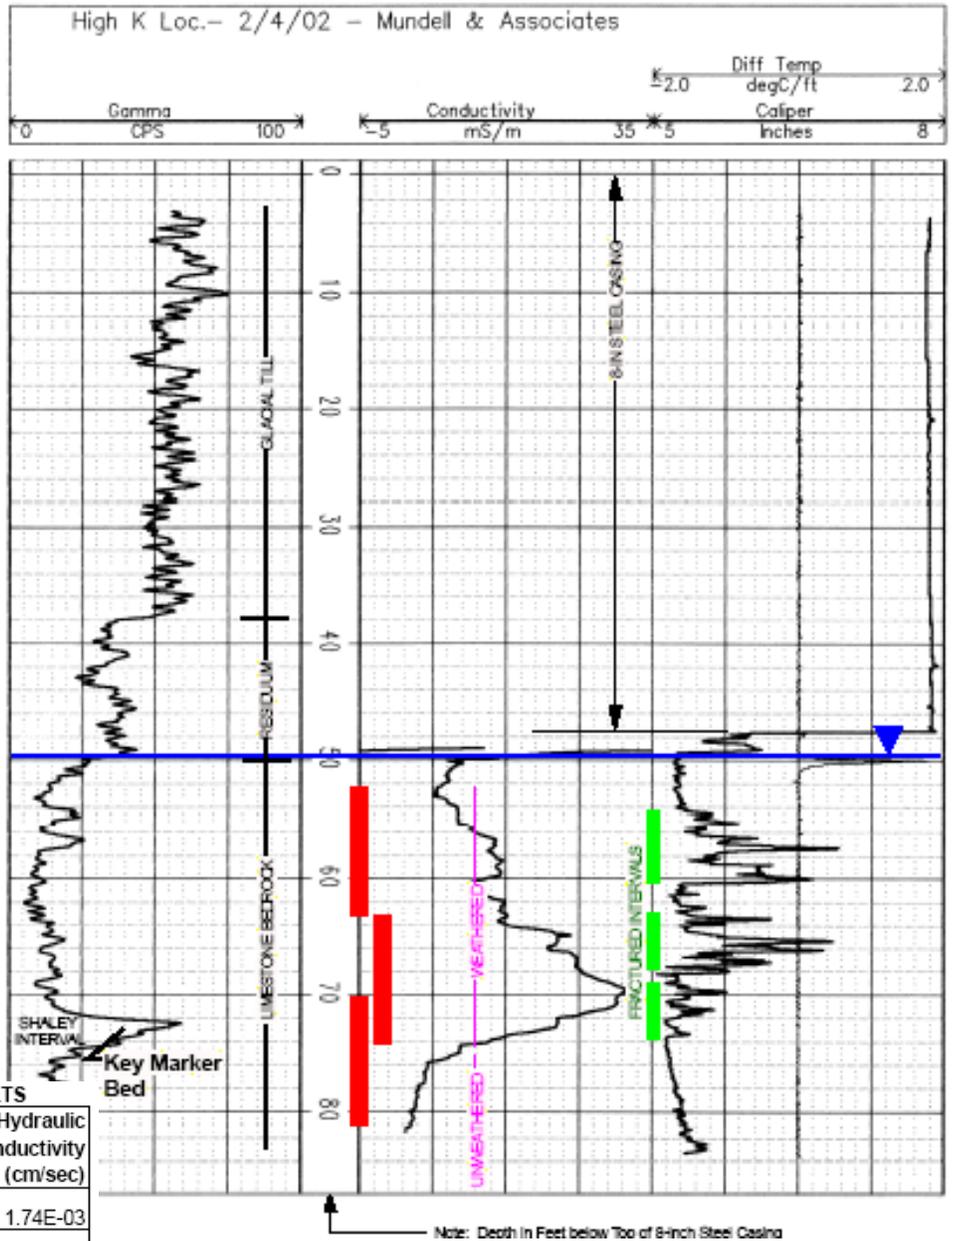
Example geophysical log and packer testing results.

Several valuable pieces of information can be derived from the caliper log. First, the location of the steel surface casing and other details related to the construction of the boring can be interpreted. Second, in the open bedrock portions of the well, the locations of potential changes in rock type and the locations of fracture zones can be interpreted. Generally, fractured rock is less resistant to mechanic forces with the result that borehole diameter will be enlarged by the drilling process in fracture zones. A larger, more irregular boring diameter will be indicated on the logs in fracture zones. In contrast, more competent rock will tend to have a much smoother appearance near the drilled borehole diameter.

The video log consists of a real-time color image of the boring with a digital notation of the camera depth on the picture. Changes in fluid, rock type, and the presence of fractures are readily apparent on the video log. After logging a downward view of the borehole, a side-view log was also completed in order to obtain a better view into some of the fracture zones.

The heat pulse flowmeter probe was operated after the other logging probes had been run. This instrument measures the rate of vertical groundwater flow within the borehole by forcing flowing groundwater to flow through a heating grid located between two thermistors and measuring the length of time necessary for a heat pulse to reach either one of the thermistors. The heat pulse flowmeter probe was used to gather information about subtle vertical groundwater flow under near steady state (unstressed) conditions. Measurements were taken at discrete intervals with the probe held steady. Vertically flowing groundwater is forced to flow through the center of the probe.
