CASE HISTORY

Ground Penetrating Radar Analysis of a Concrete Spillway

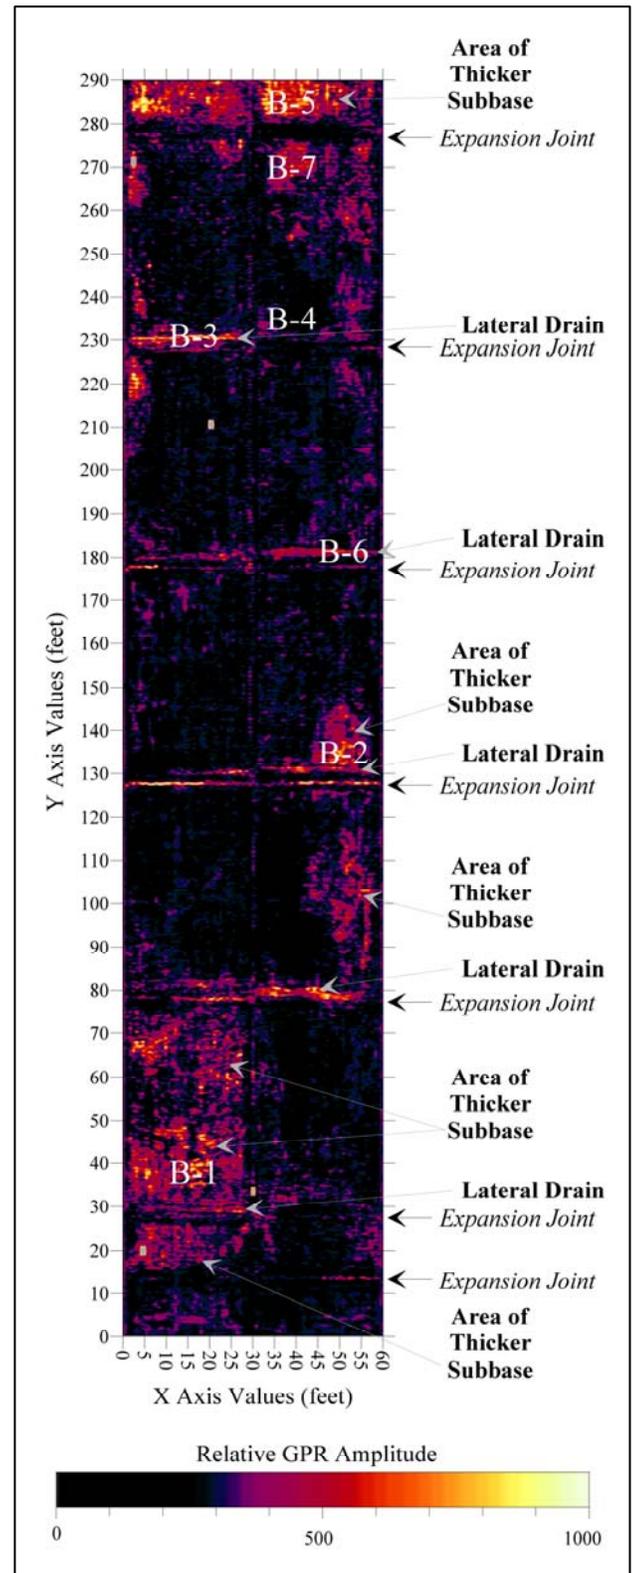
After processing and analyzing the composited average amplitude GPR response at various depth slices, the 1.20 to 2.00 feet depth interval map was selected as most relevant to the project objectives (see Figure at right). Test borings of the high amplitude anomalies on this map (B-1 through B-7) indicated areas of thicker subbase materials as well a system of lateral sub-concrete drains installed in anticipation of water flow beneath the spillway. The GPR investigation revealed the source of the outflow from beneath the slabs and verified that the subbase materials were sound.

In order to keep project costs to a minimum, the project engineer commissioned a geophysical investigation to map the location of potential voids below the concrete using non-destructive means. Identified voids underneath the spillway were to be remediated with grout pumped into the subbase of the concrete.
