## CASE HISTORY

### Pipeline Subsidence Study Using Geophysics

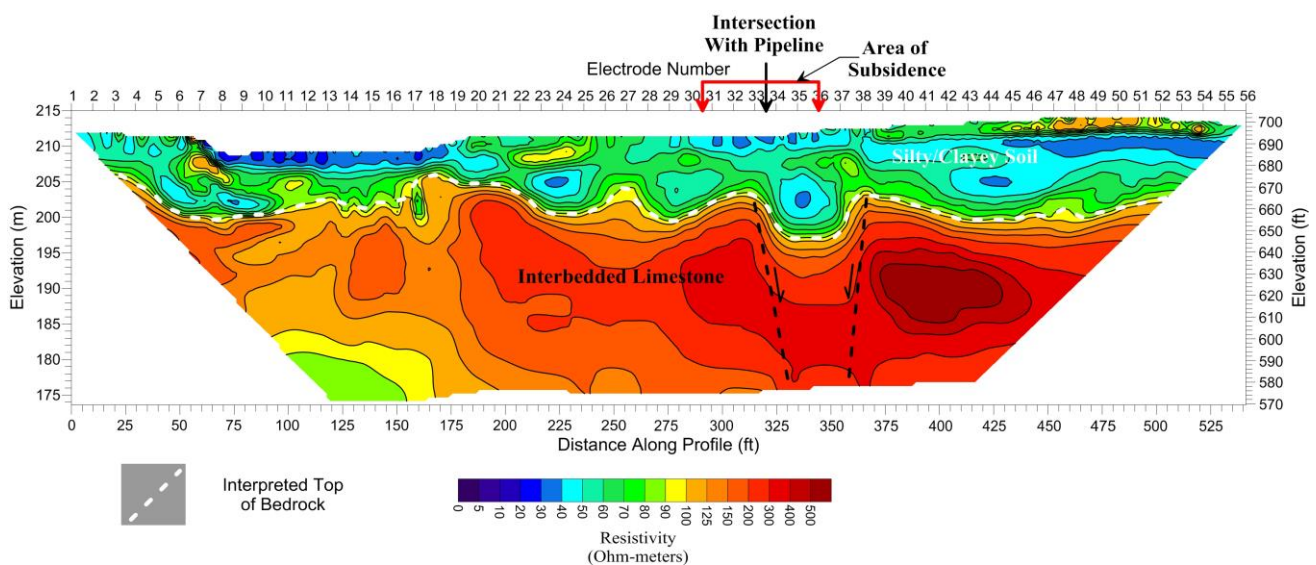
The resistivity profiles indicated that the bedrock surface was undulating and weathered, and the data collected across this feature clearly indicates that a pit-like feature was developing into the bedrock, which appeared to have collapsed approximately 10-15 feet. Thus, geophysical data showed that the shallow subsidence along the pipeline was caused by deep, vertical soil movement, which was likely the result of a mine collapse.
